## **Municipal Class Environmental Assessment – Schedule B**

### **Project File Report**

Road Network Expansion  
417 Industrial Park, Township of Russell ON

LRL File No.: 230216.00  
Project No.: C0821-22048

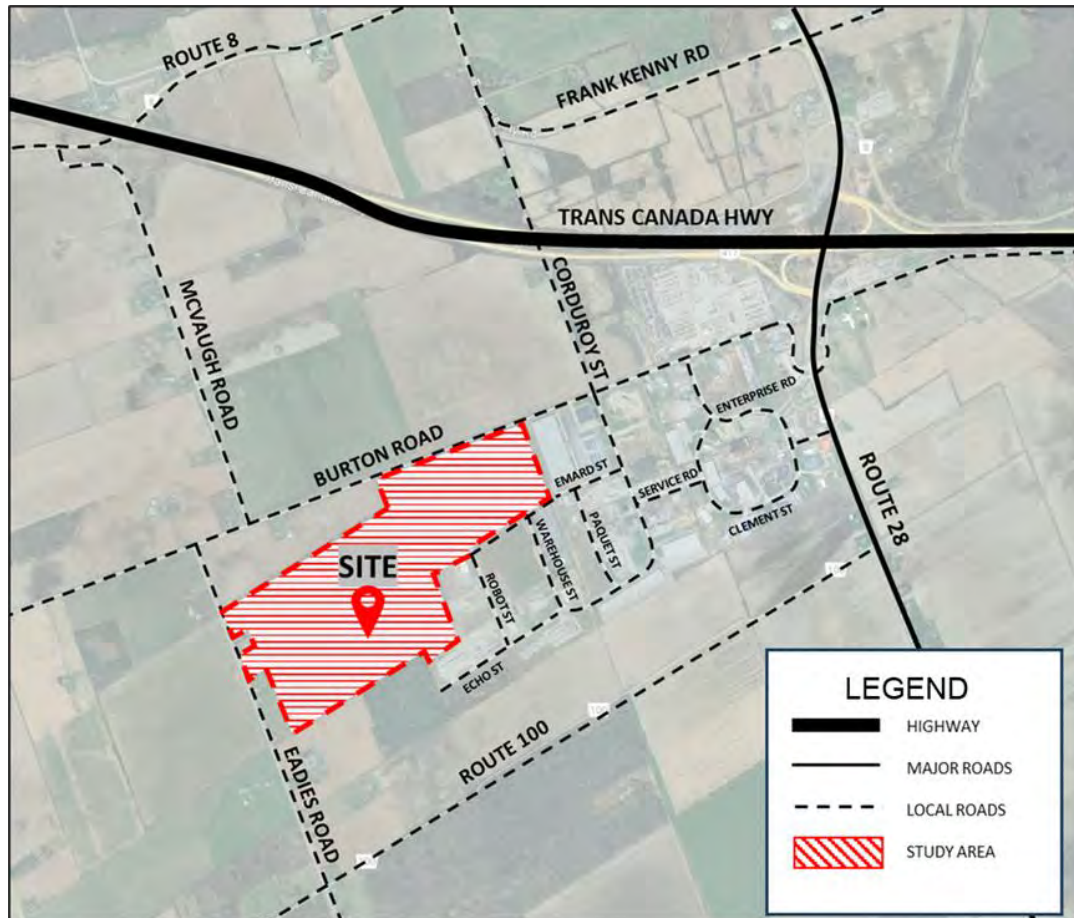
Figure 1: Study Area

The 417 Industrial Park is bordered to the north by Burton Road, to the west by Eadie Road, and to the south by a future road right-of-way referred to as Route 100. The portion of the industrial park that is being reviewed for the roadway extension is the land located west of where Emard Road currently terminates, and north of Robot Street. The study area is captured in in **Figure 1** below.

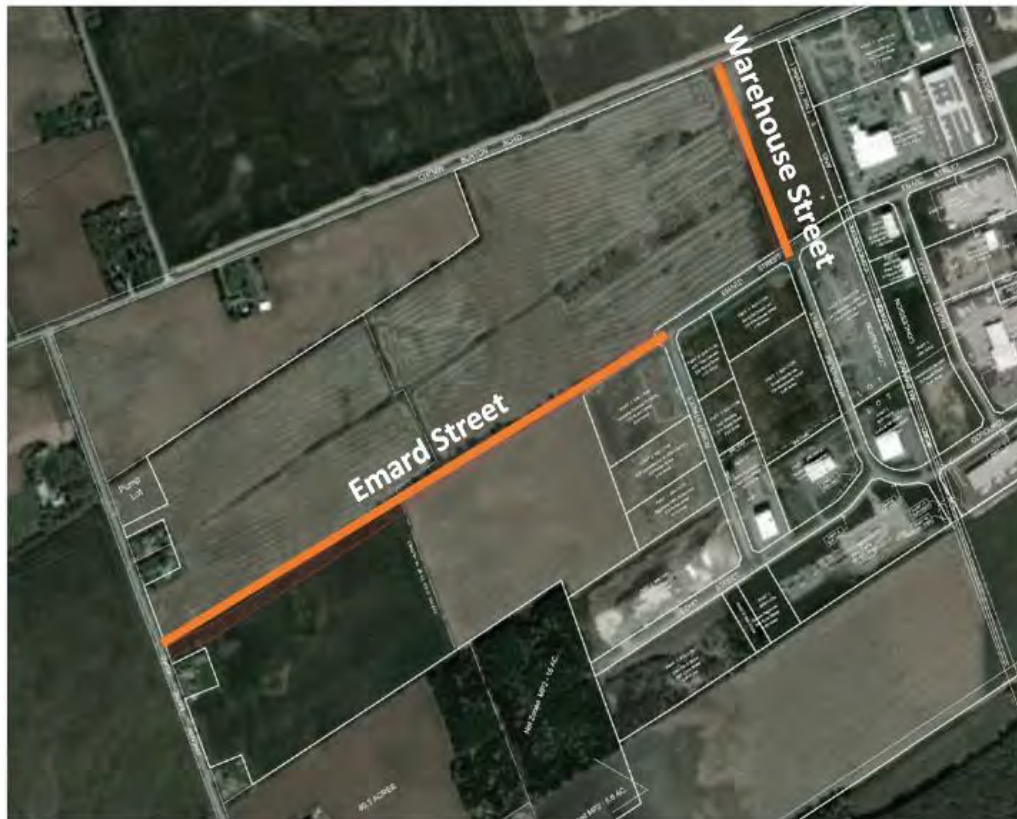
Figure 2: Option 1 - Emard Street and Warehouse Street Extension

The full-length extension of Emard Street along the subject site up to Eadie Road and Warehouse Street with full-length extension as well to Burton Road was proposed as one of the alternatives, as indicated in **Figure 2**

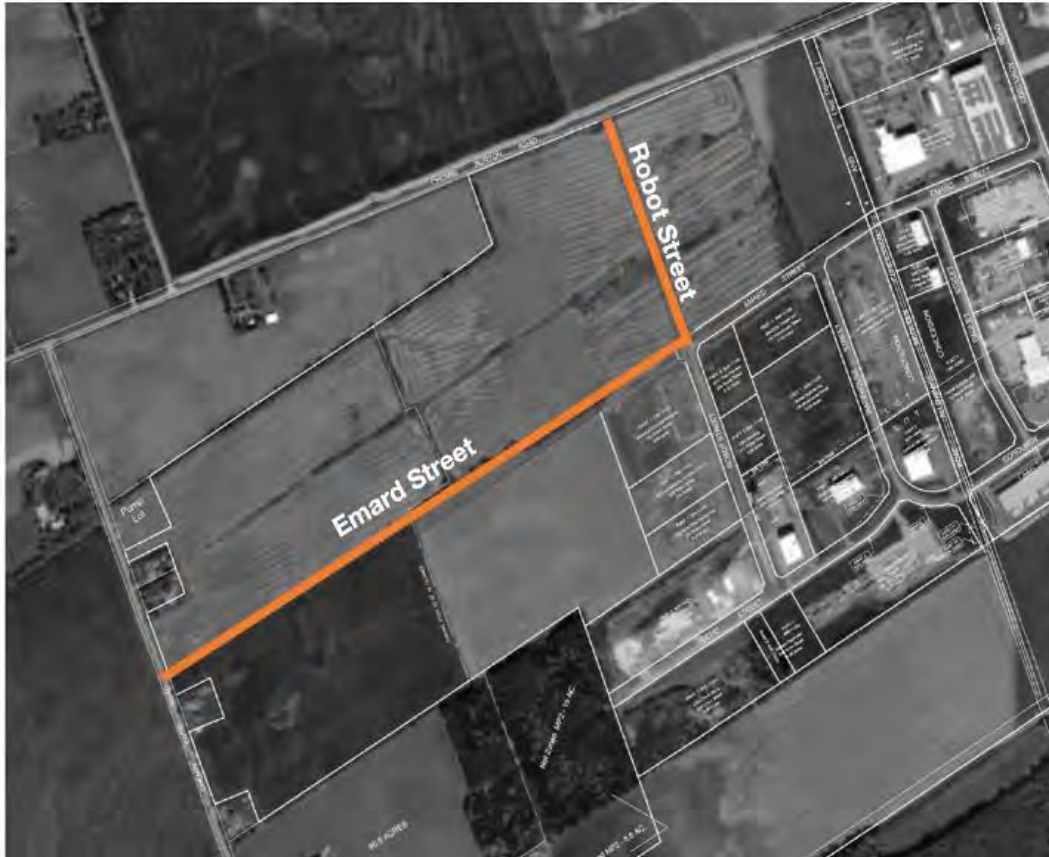
Figure 3: Option 2- Emard Street and Robot Street Extension

Emard Street would extend along the subject site up to Eadie Road on full length and Robot Street to Burton Road, as indicated in **Figure 3**. Although this proposed solution received the highest points among other options (35 points), it was halted following the public information session as a non-viable option after considering additional influences such as public safety, fire protection, cost, and implications on the nearby dwelling fronting Eadie Road.

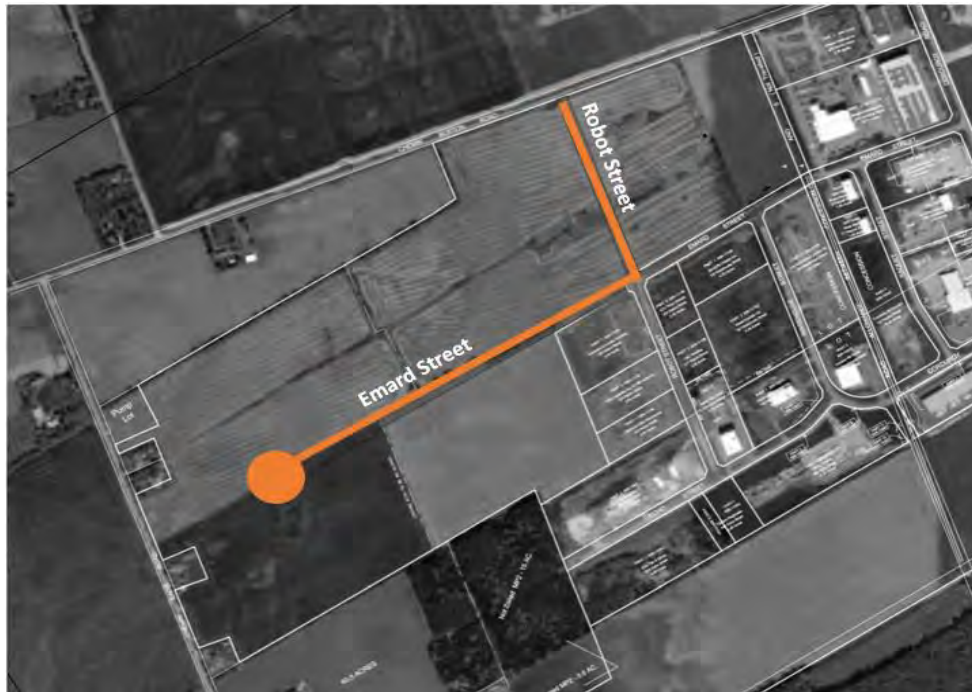
Figure 4: Option 3- Robot Street Extension with Emard Cul-de-sac

Emard Street will extend towards Eadie Road, with a cul-de-sac at the end, while Robot Street will run its full length up to Burton Road, as shown in **Figure 4**. This plan is the approved option for the road extension, considering public feedback, safety considerations, and other factors.

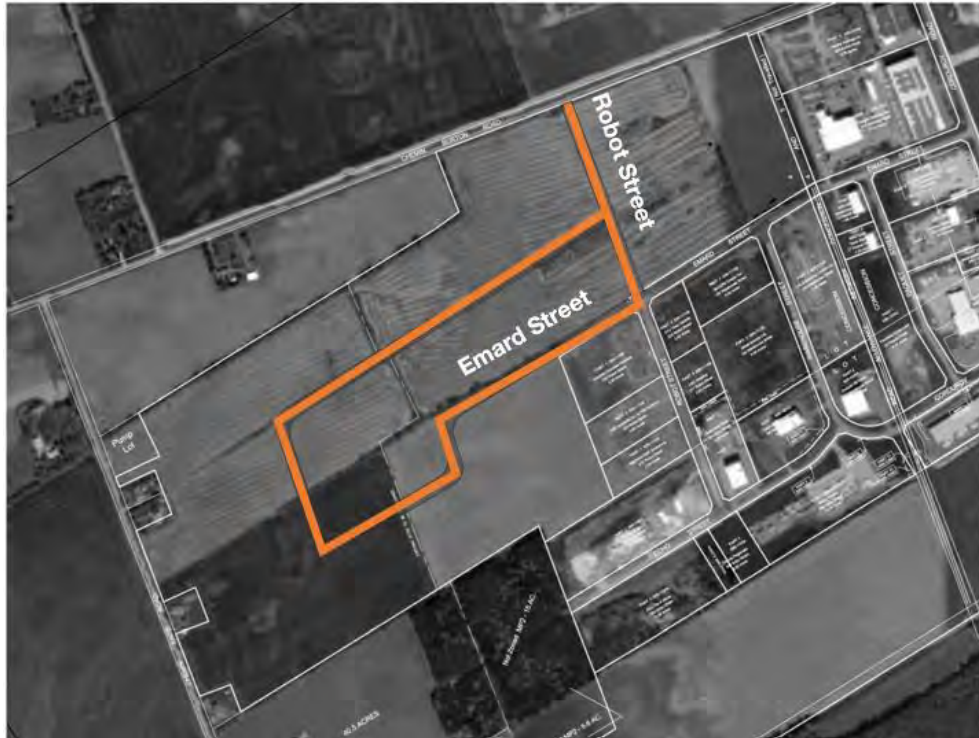
Figure 5: Option 4- Robot Street Extension with Internal Circulation

This layout would ensure connectivity throughout the area, however, limits the future lotting of the overall land.

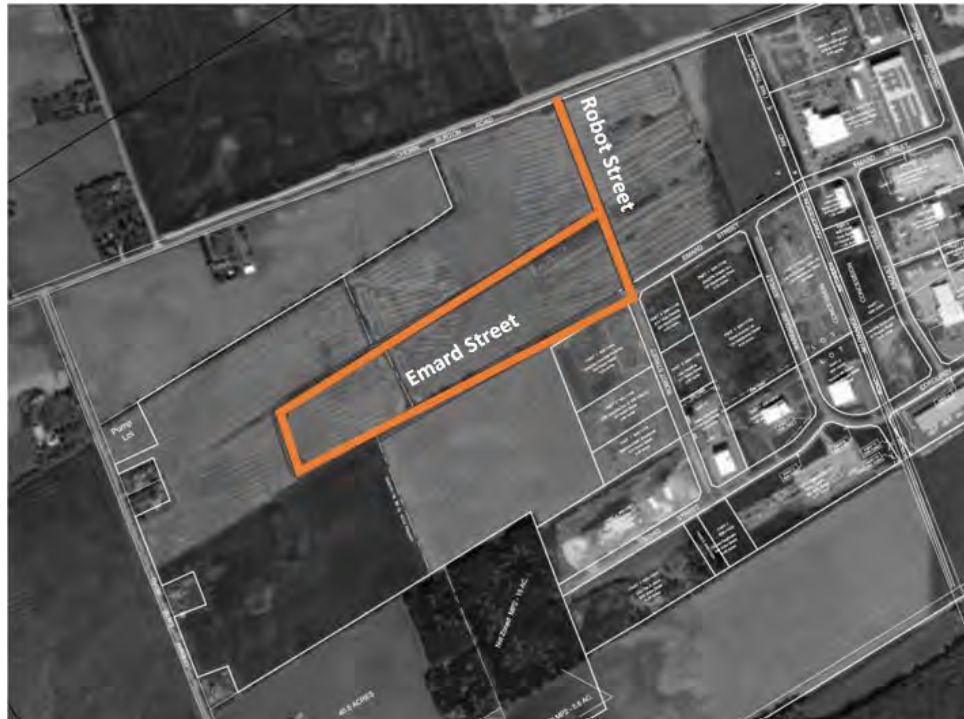
Figure 6: Option 5: Extension of Robot Street and Extension of Emard Street Networking Back to Robot

In this option, Robot Street would be extended to connect directly with Burton Road, while Emard Street would be extended and turned back to intersect with Robot Street as depicted in **Figure 6**.

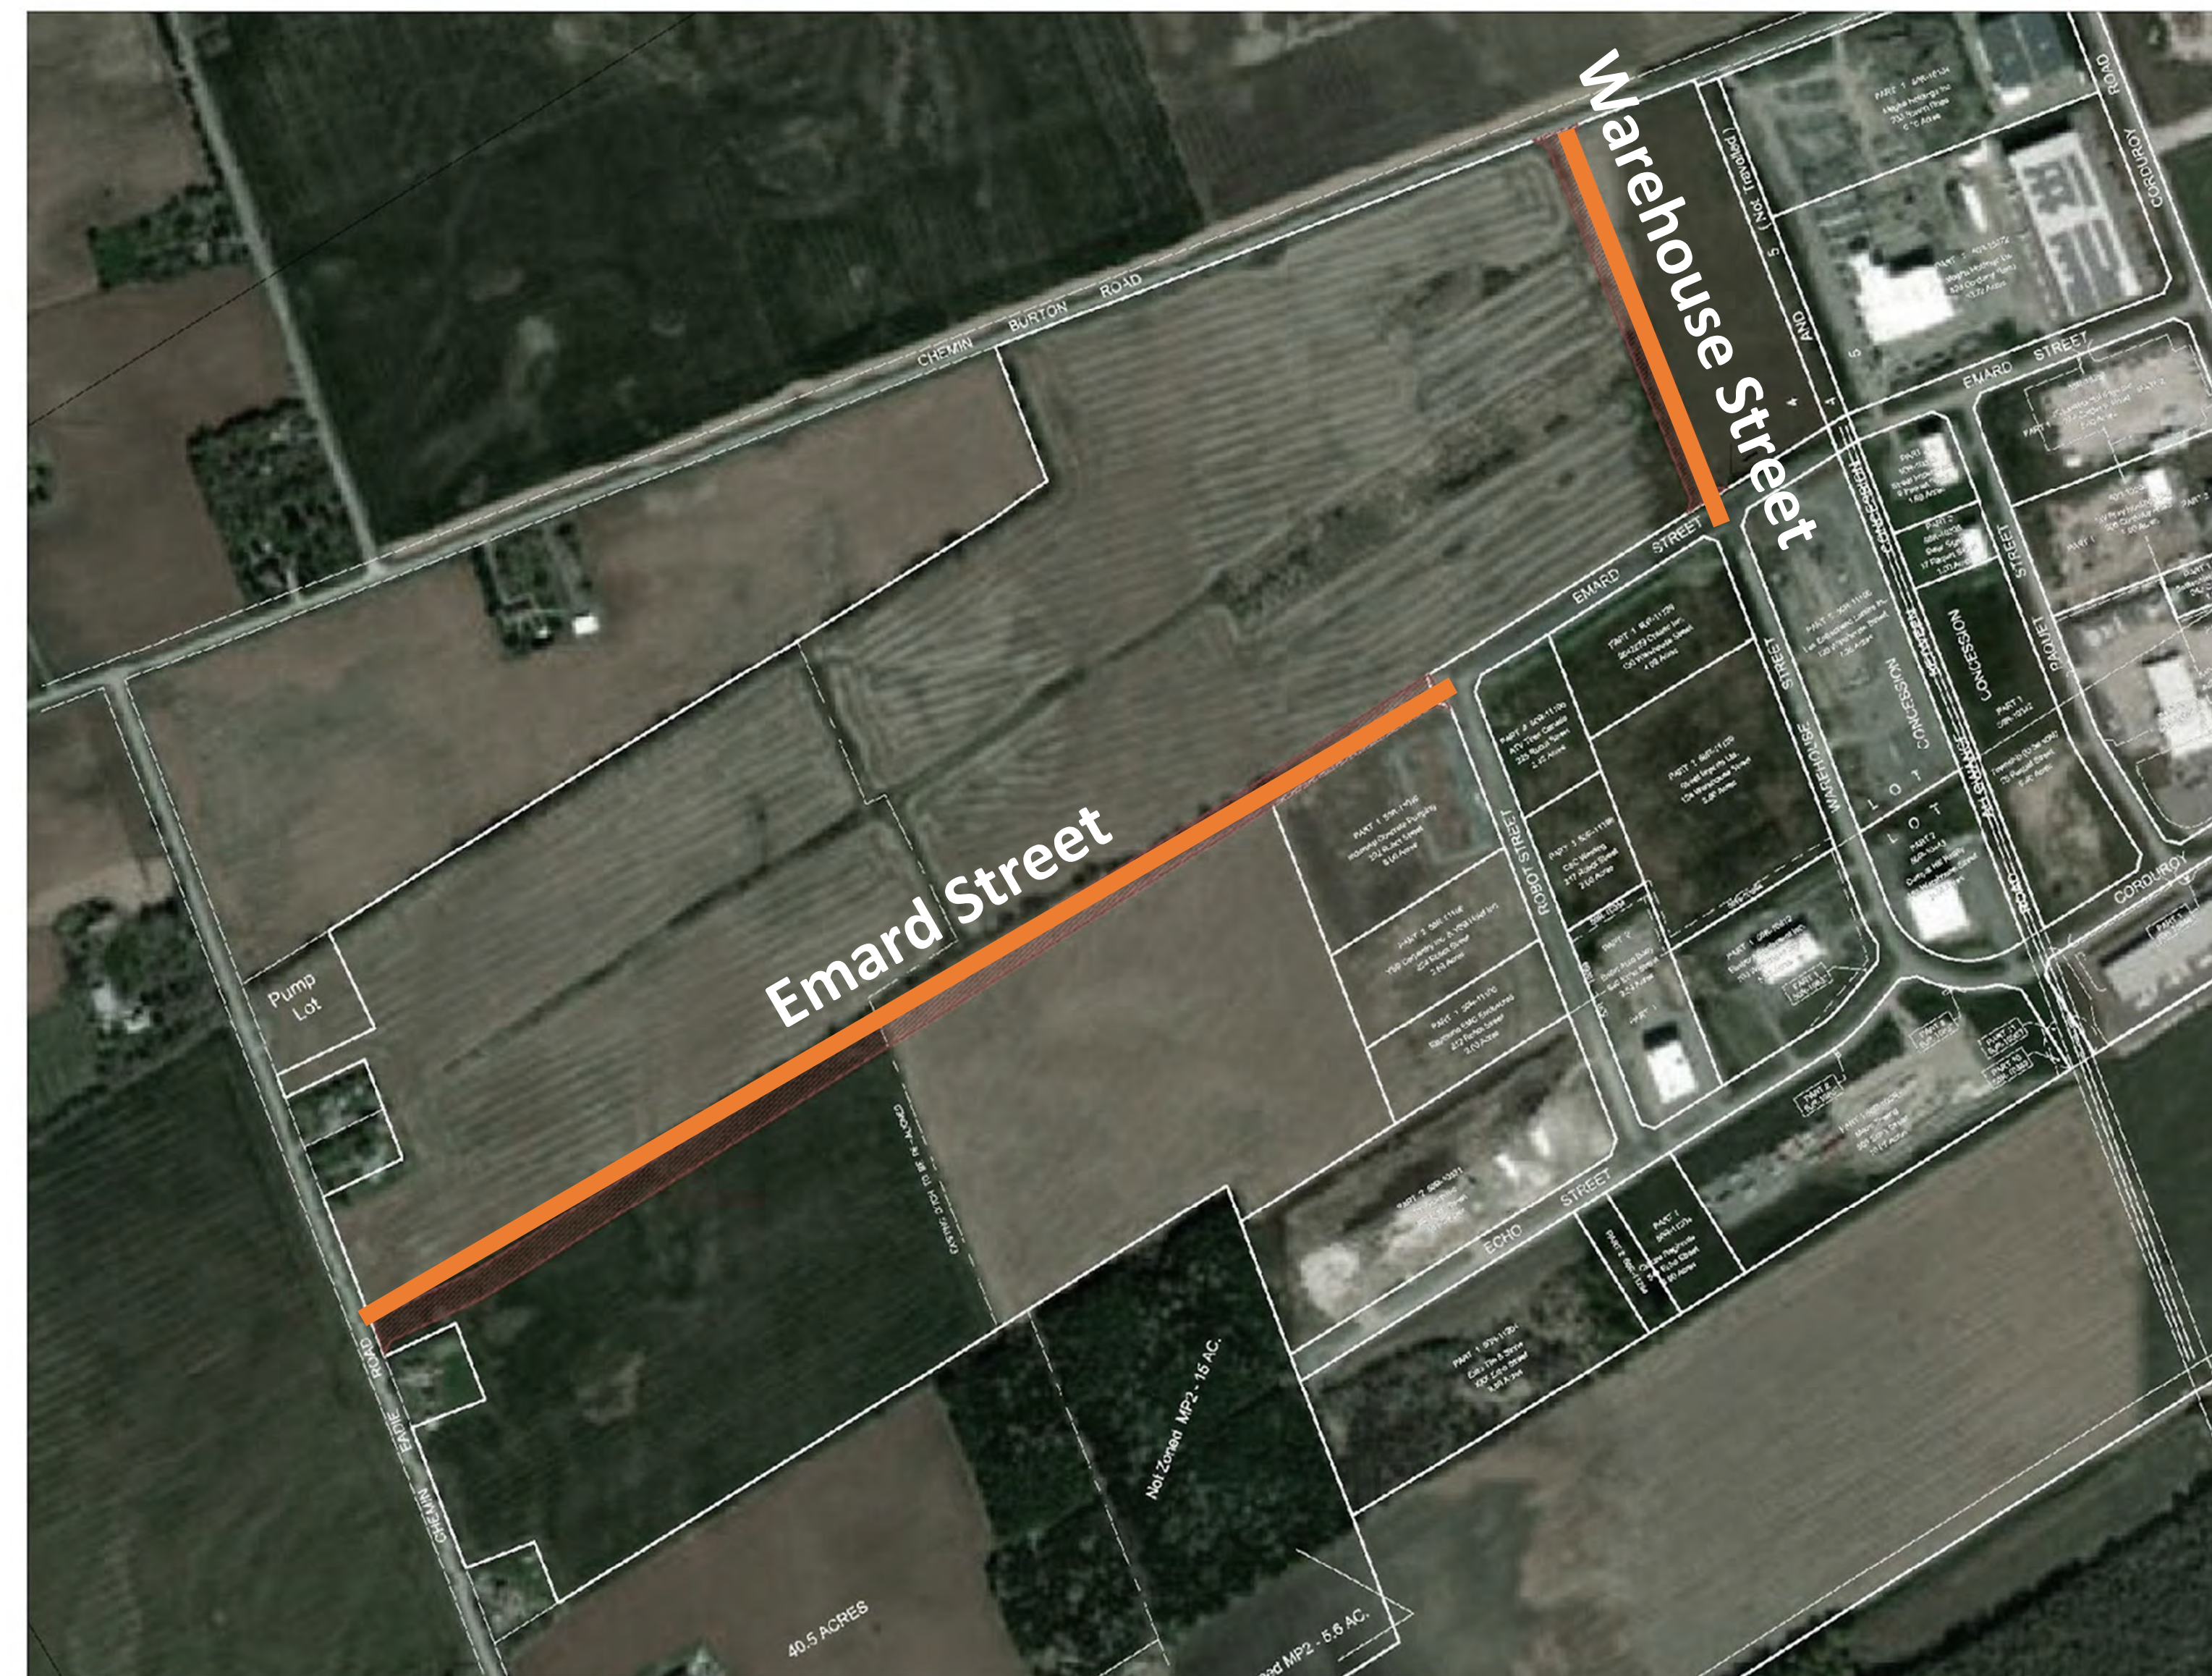
*Option 1: Full length extension of Emard Street and Warehouse Street*

<b>Environmental Aspects</b>	Natural Environment Impact	Emard Street intersects with existing Municipal Drain branch, road construction will have a moderate impact to natural environment.	2
<b>Cost &amp; Constructability</b>	Constructability	Simplistic geometric road layout design aides in buildability.	5
	Construction Cost	Shorter road length results in less construction costs for road.	4
<b>Total</b>			<b>33</b>

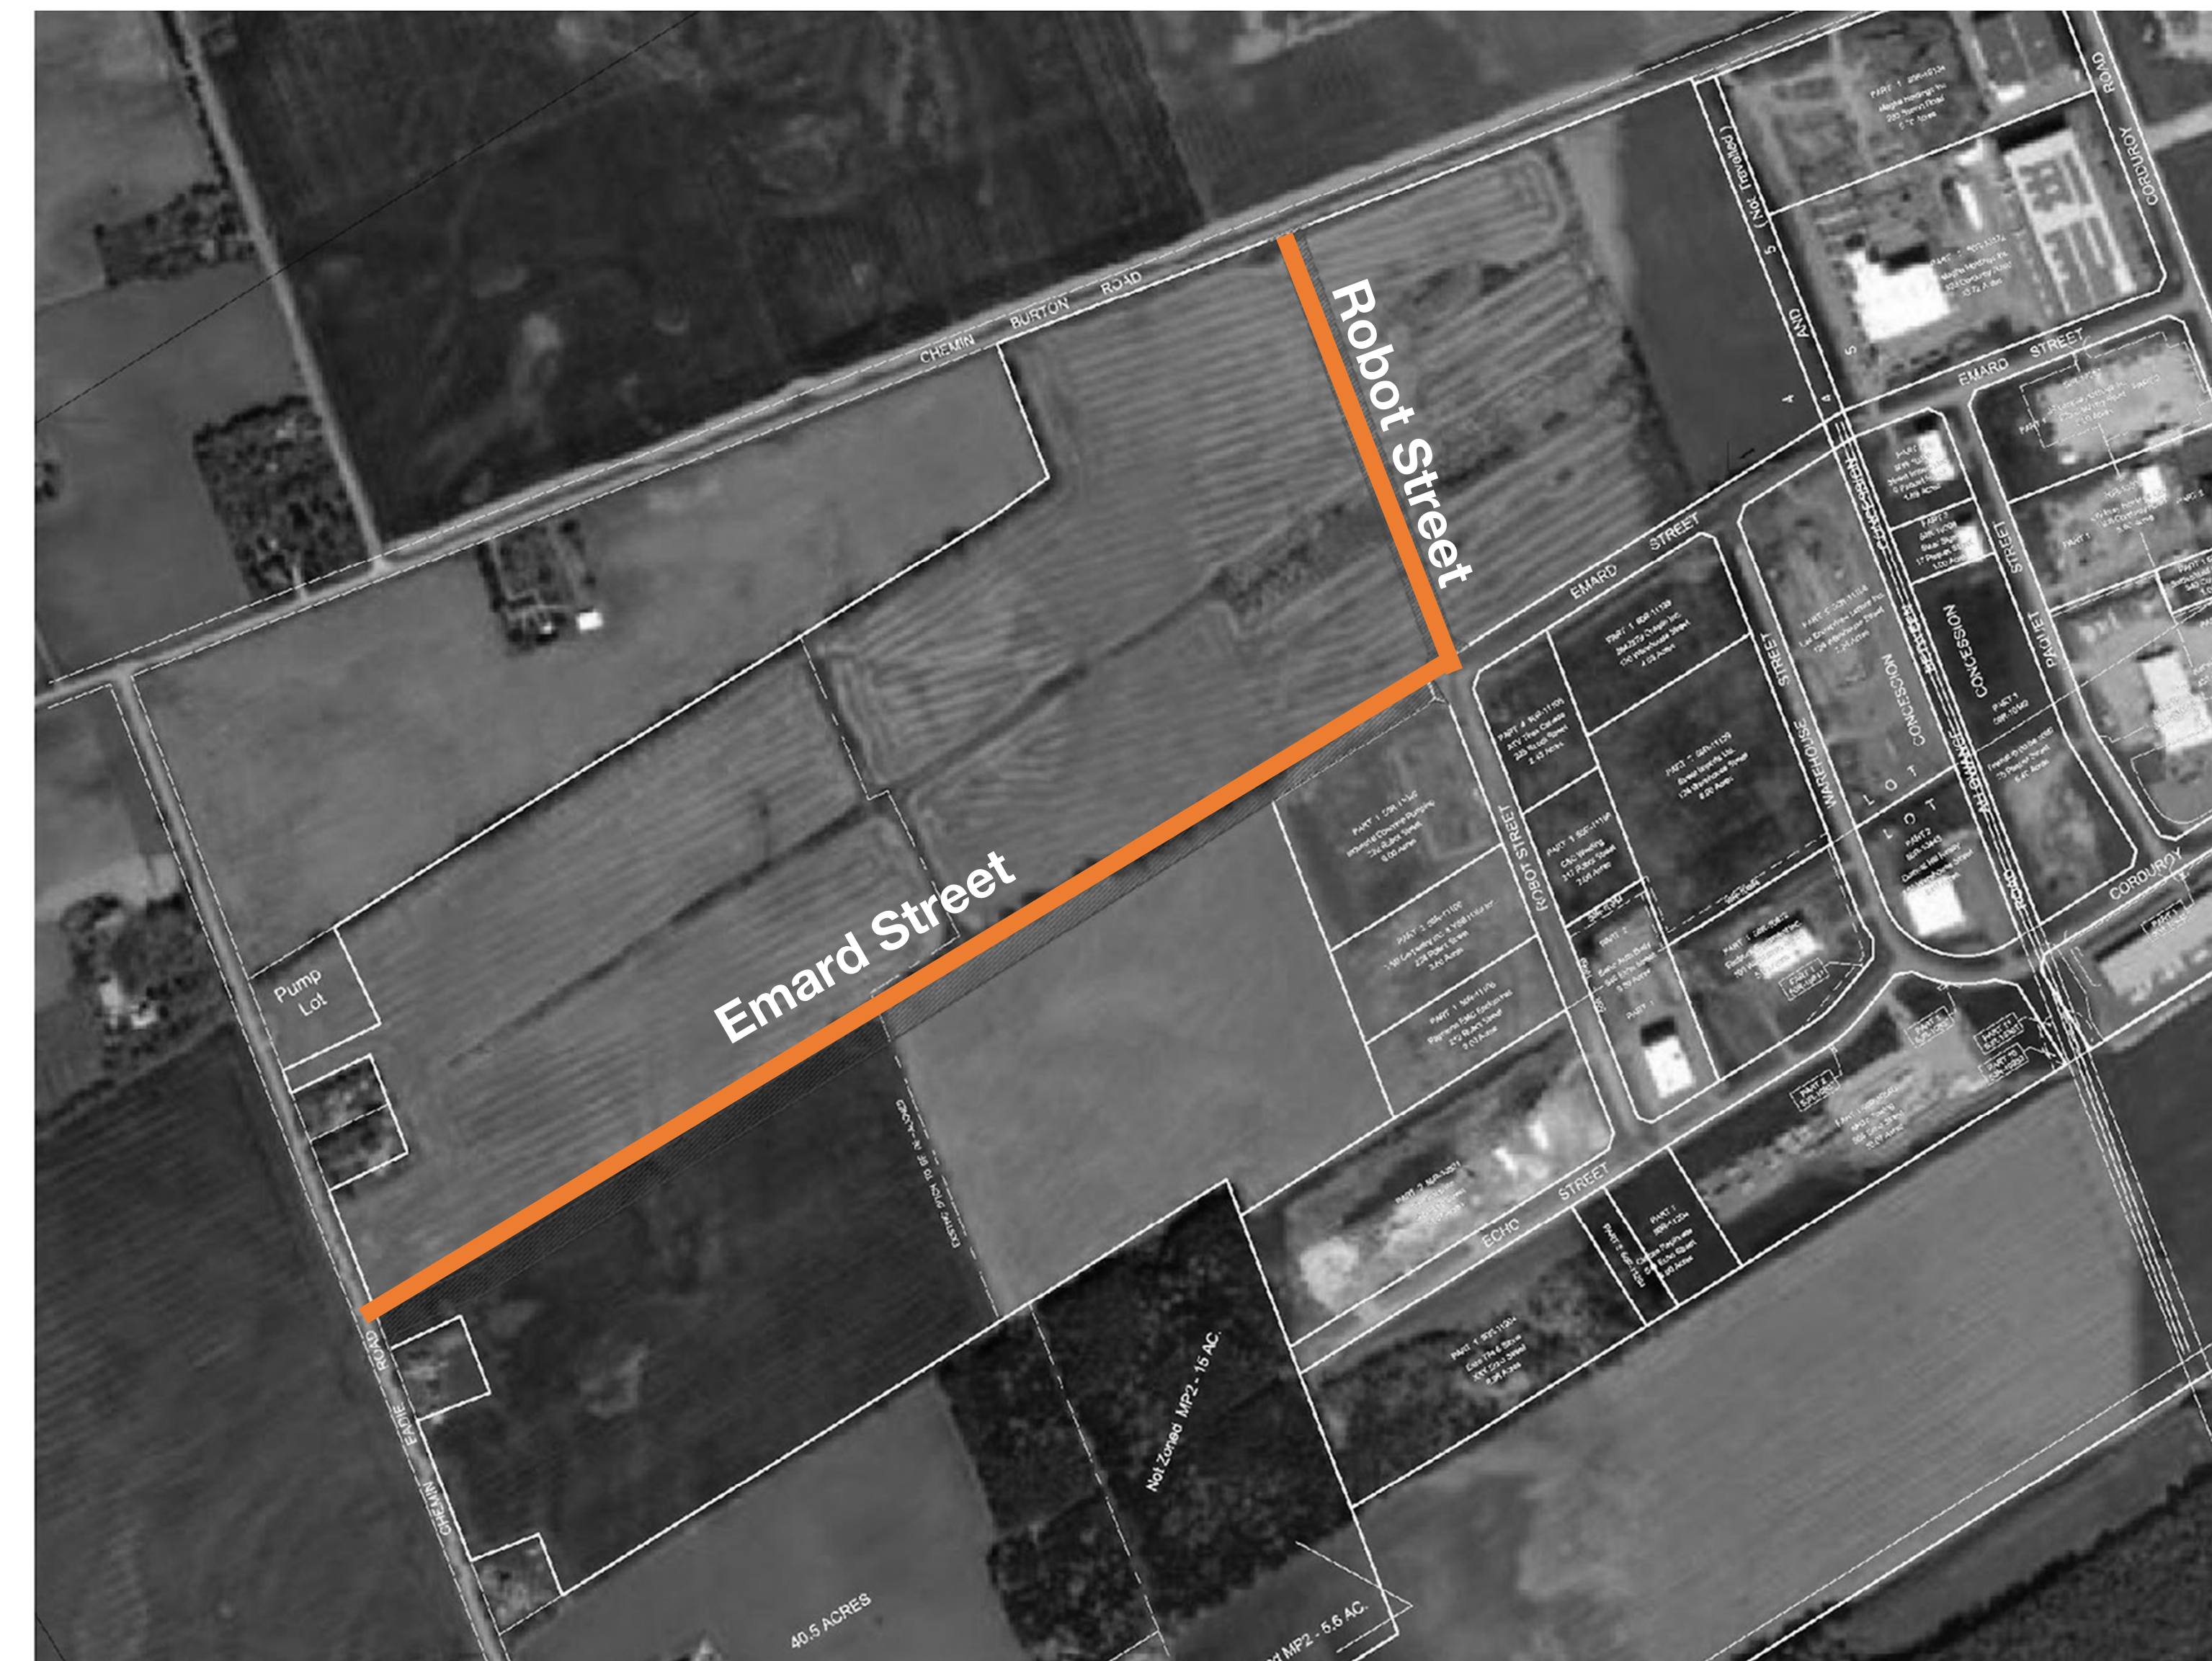
**Option 2: Full length extension of Emard Street and Robot Street**

<b>Cost &amp; Constructability</b>	Constructability	Simplistic geometric road layout design aides in buildability.	5
	Construction Cost	Shorter road length results in less construction costs for road.	4
<b>Total</b>			<b>35</b>

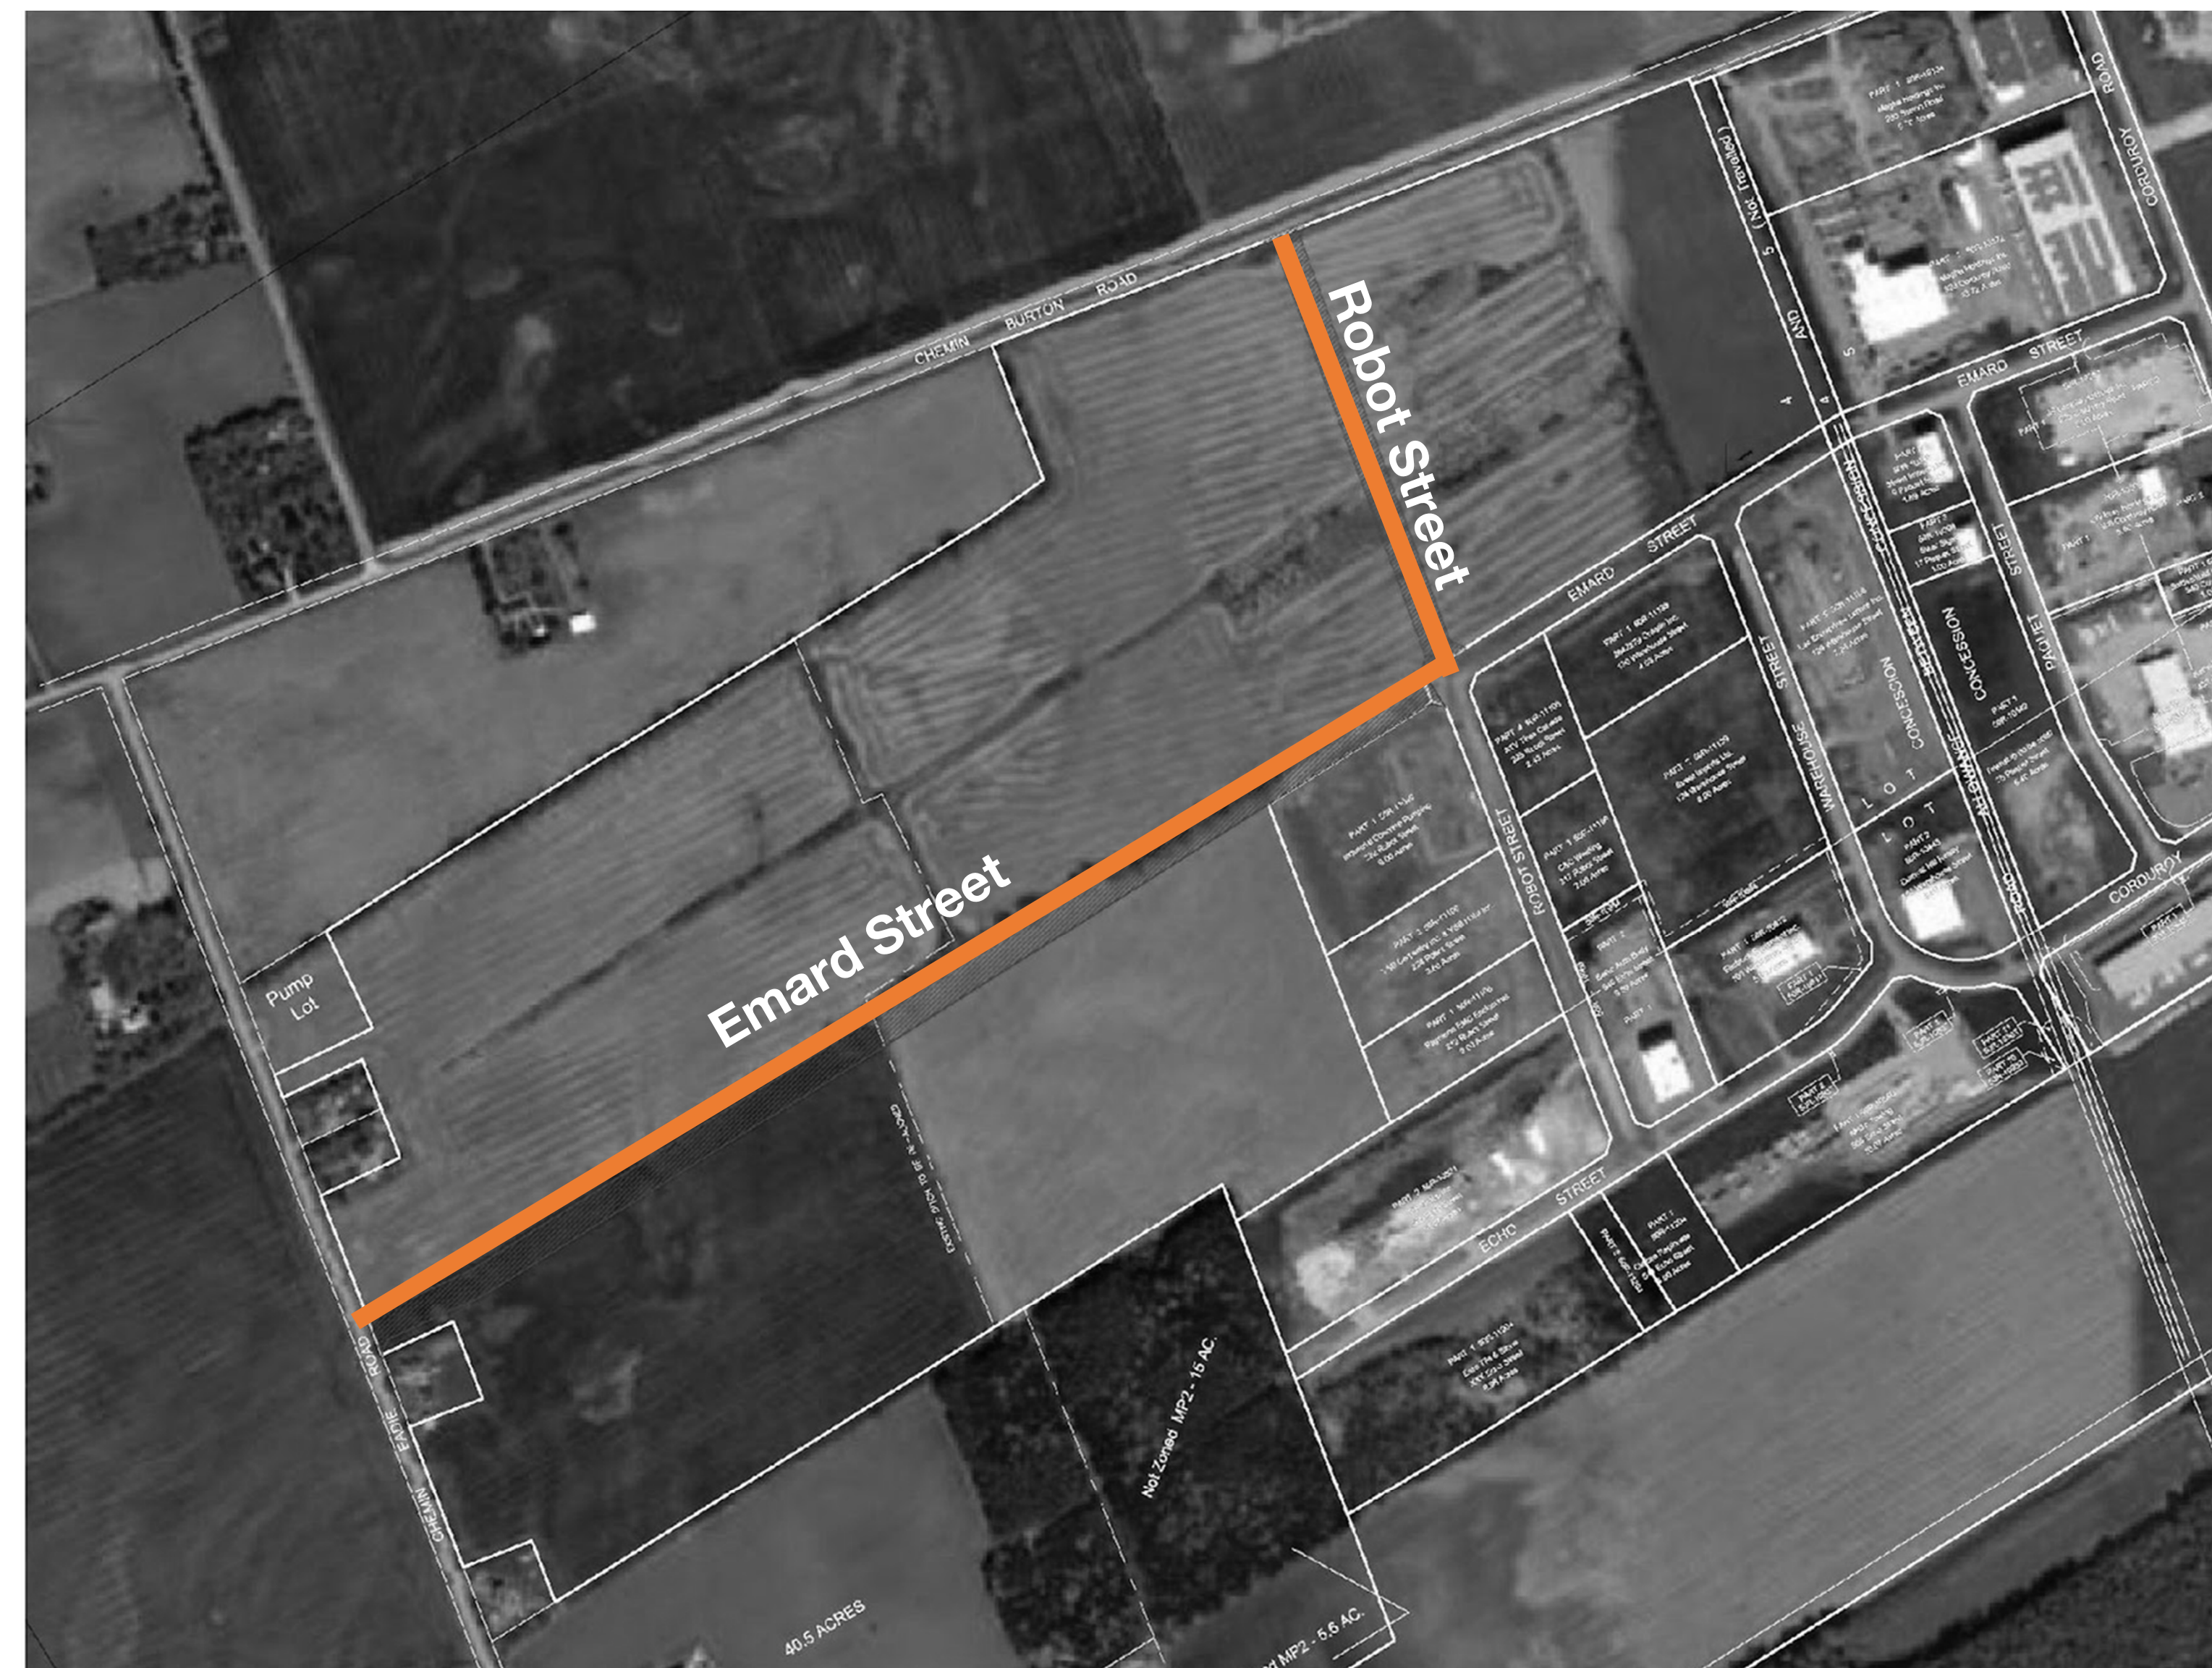
**Option 2:** Extension des rues Emard et Robot

<b>Coûts &amp; faisabilité</b>	Faisabilité	La simplicité de la géométrie permet plusieurs scénario de construction.	5
	Coûts de construction	Rues plus courtes = coûts moindres.	4

**Total** 35

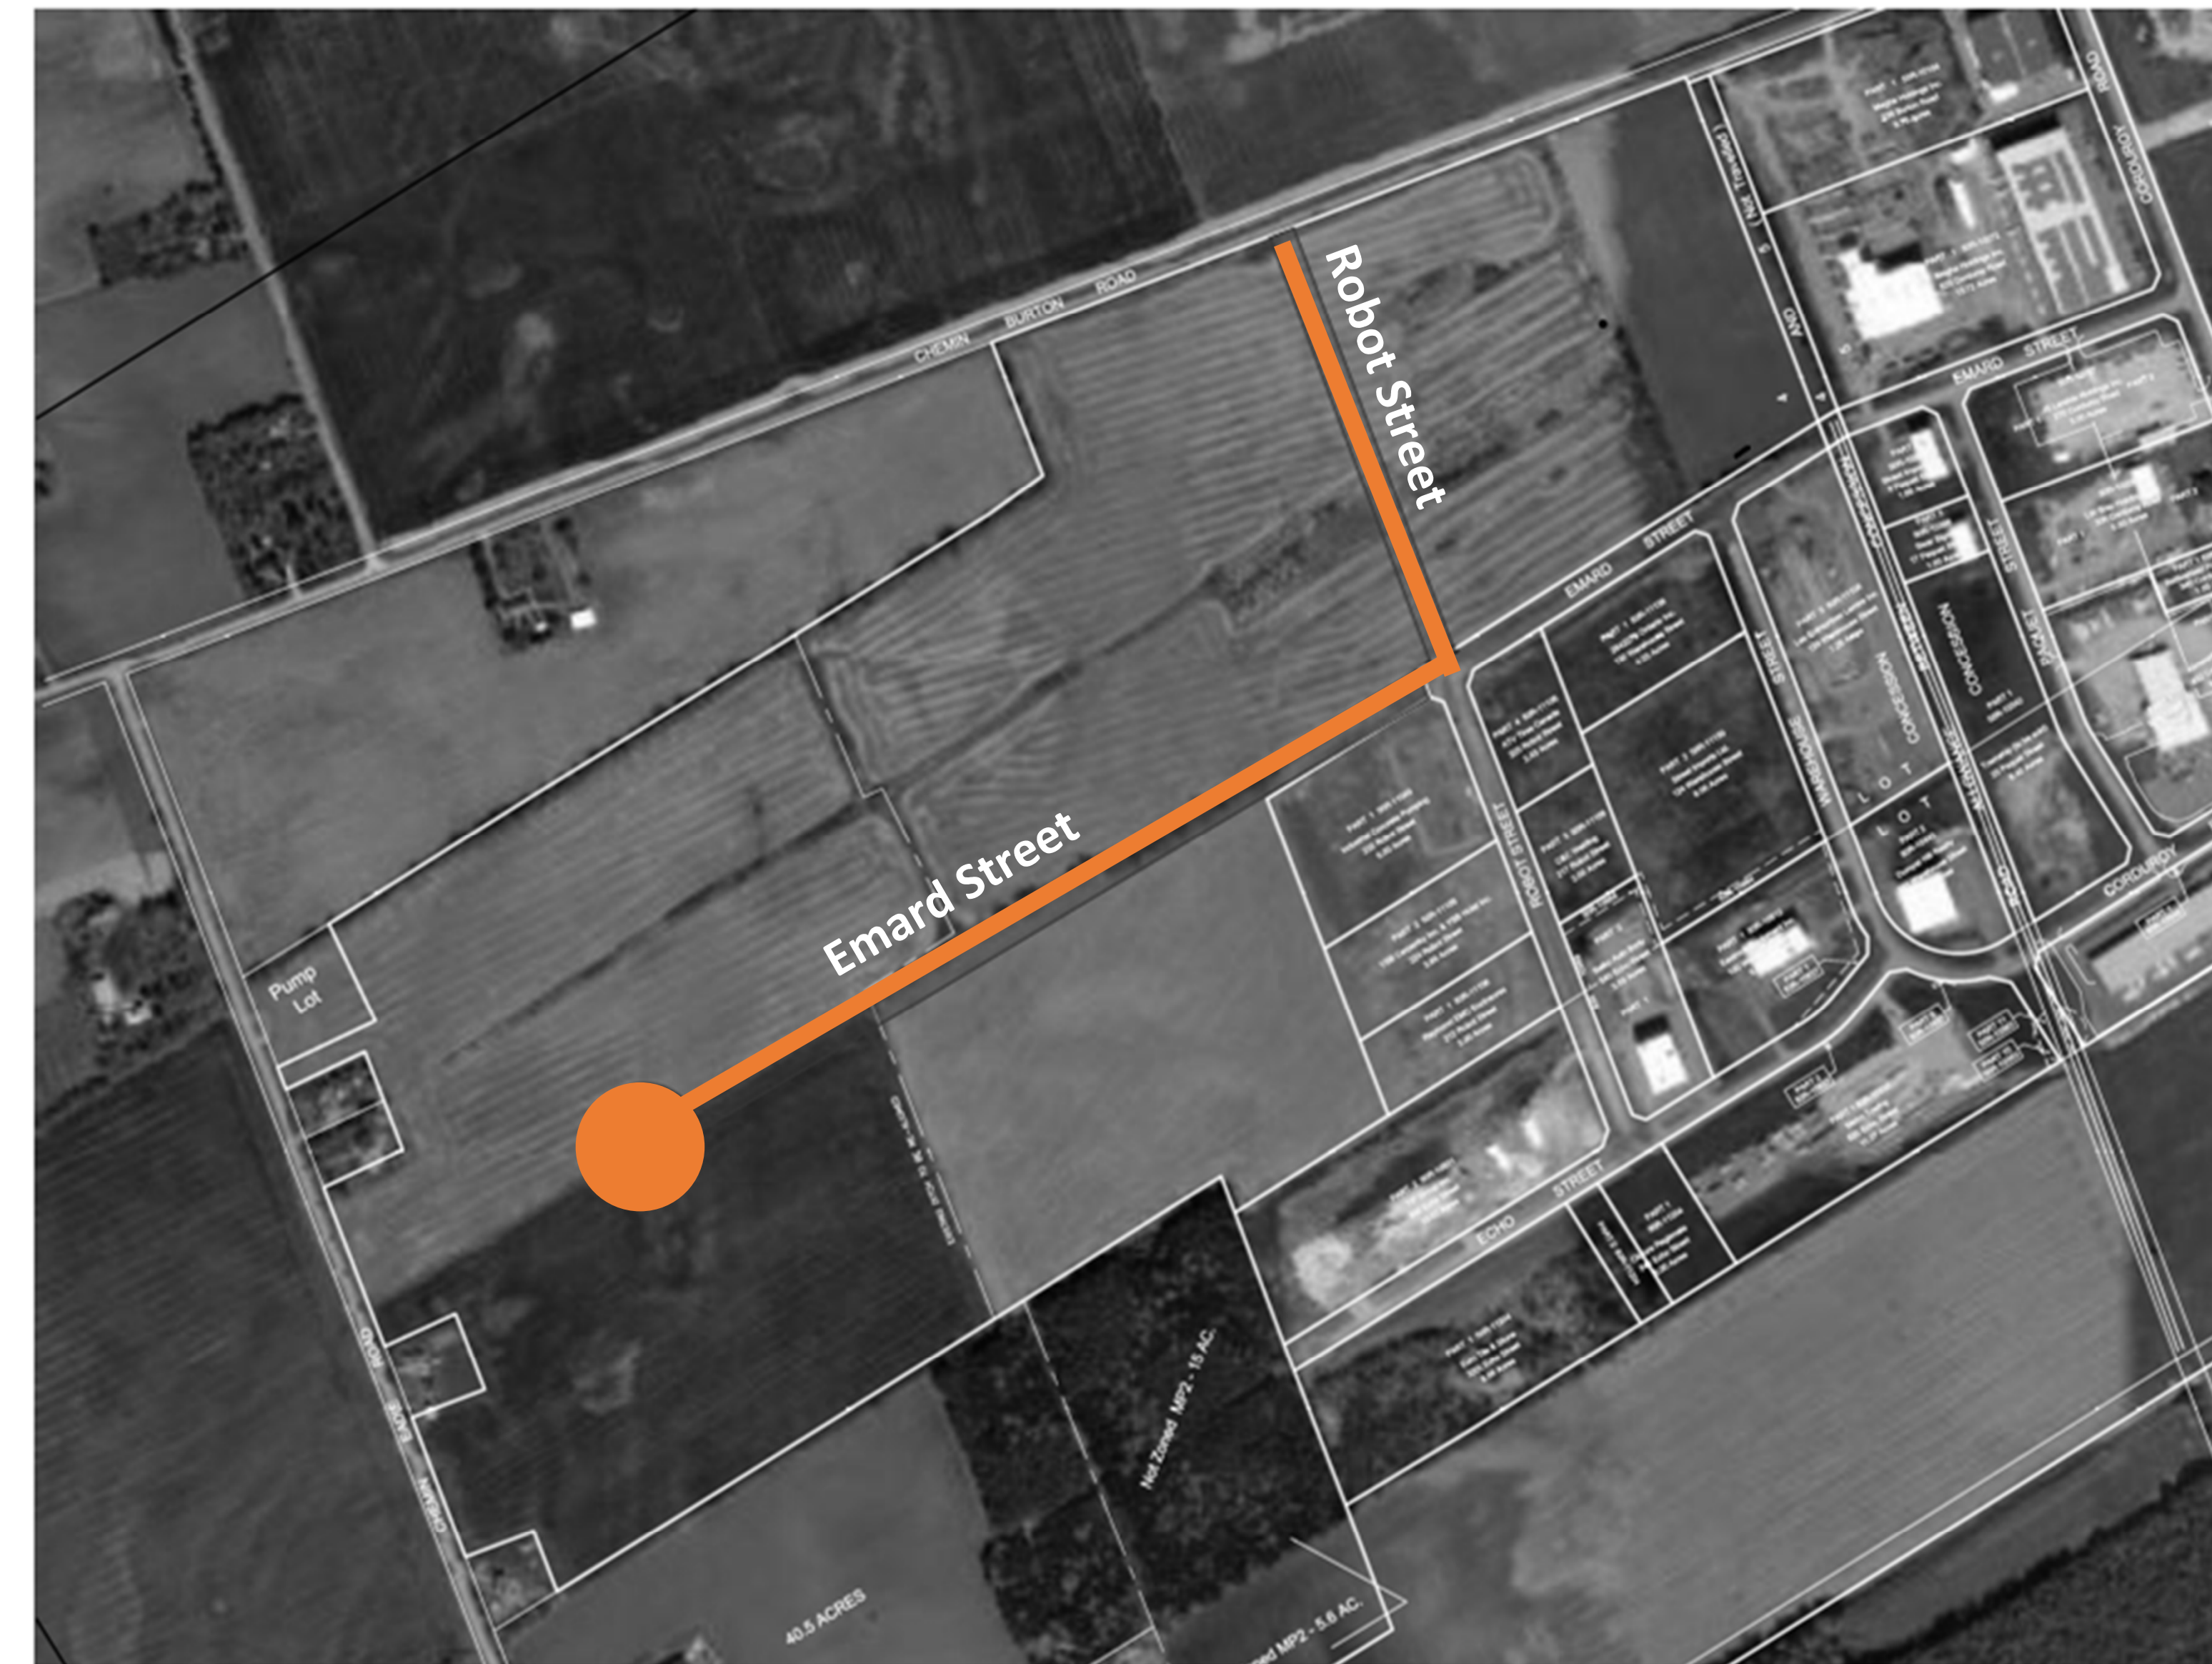
*Option 3: Cul-De-Sac at Emard Street and extension of Robot Street*

<b>Cost &amp; Constructability</b>	Constructability	Simplistic geometric road layout design aides in buildability. Consideration required for drainage of site around round-a-bout.	4
	Construction Cost	Shortest road length results in less construction costs for road.	5
<b>Total</b>			<b>30</b>
