## **Municipal Class Environmental Assessment – Schedule B**

### **Project File Report**

Road Network Expansion  
417 Industrial Park, Township of Russell ON

LRL File No.: 230216.00  
Project No.: C0821-22048

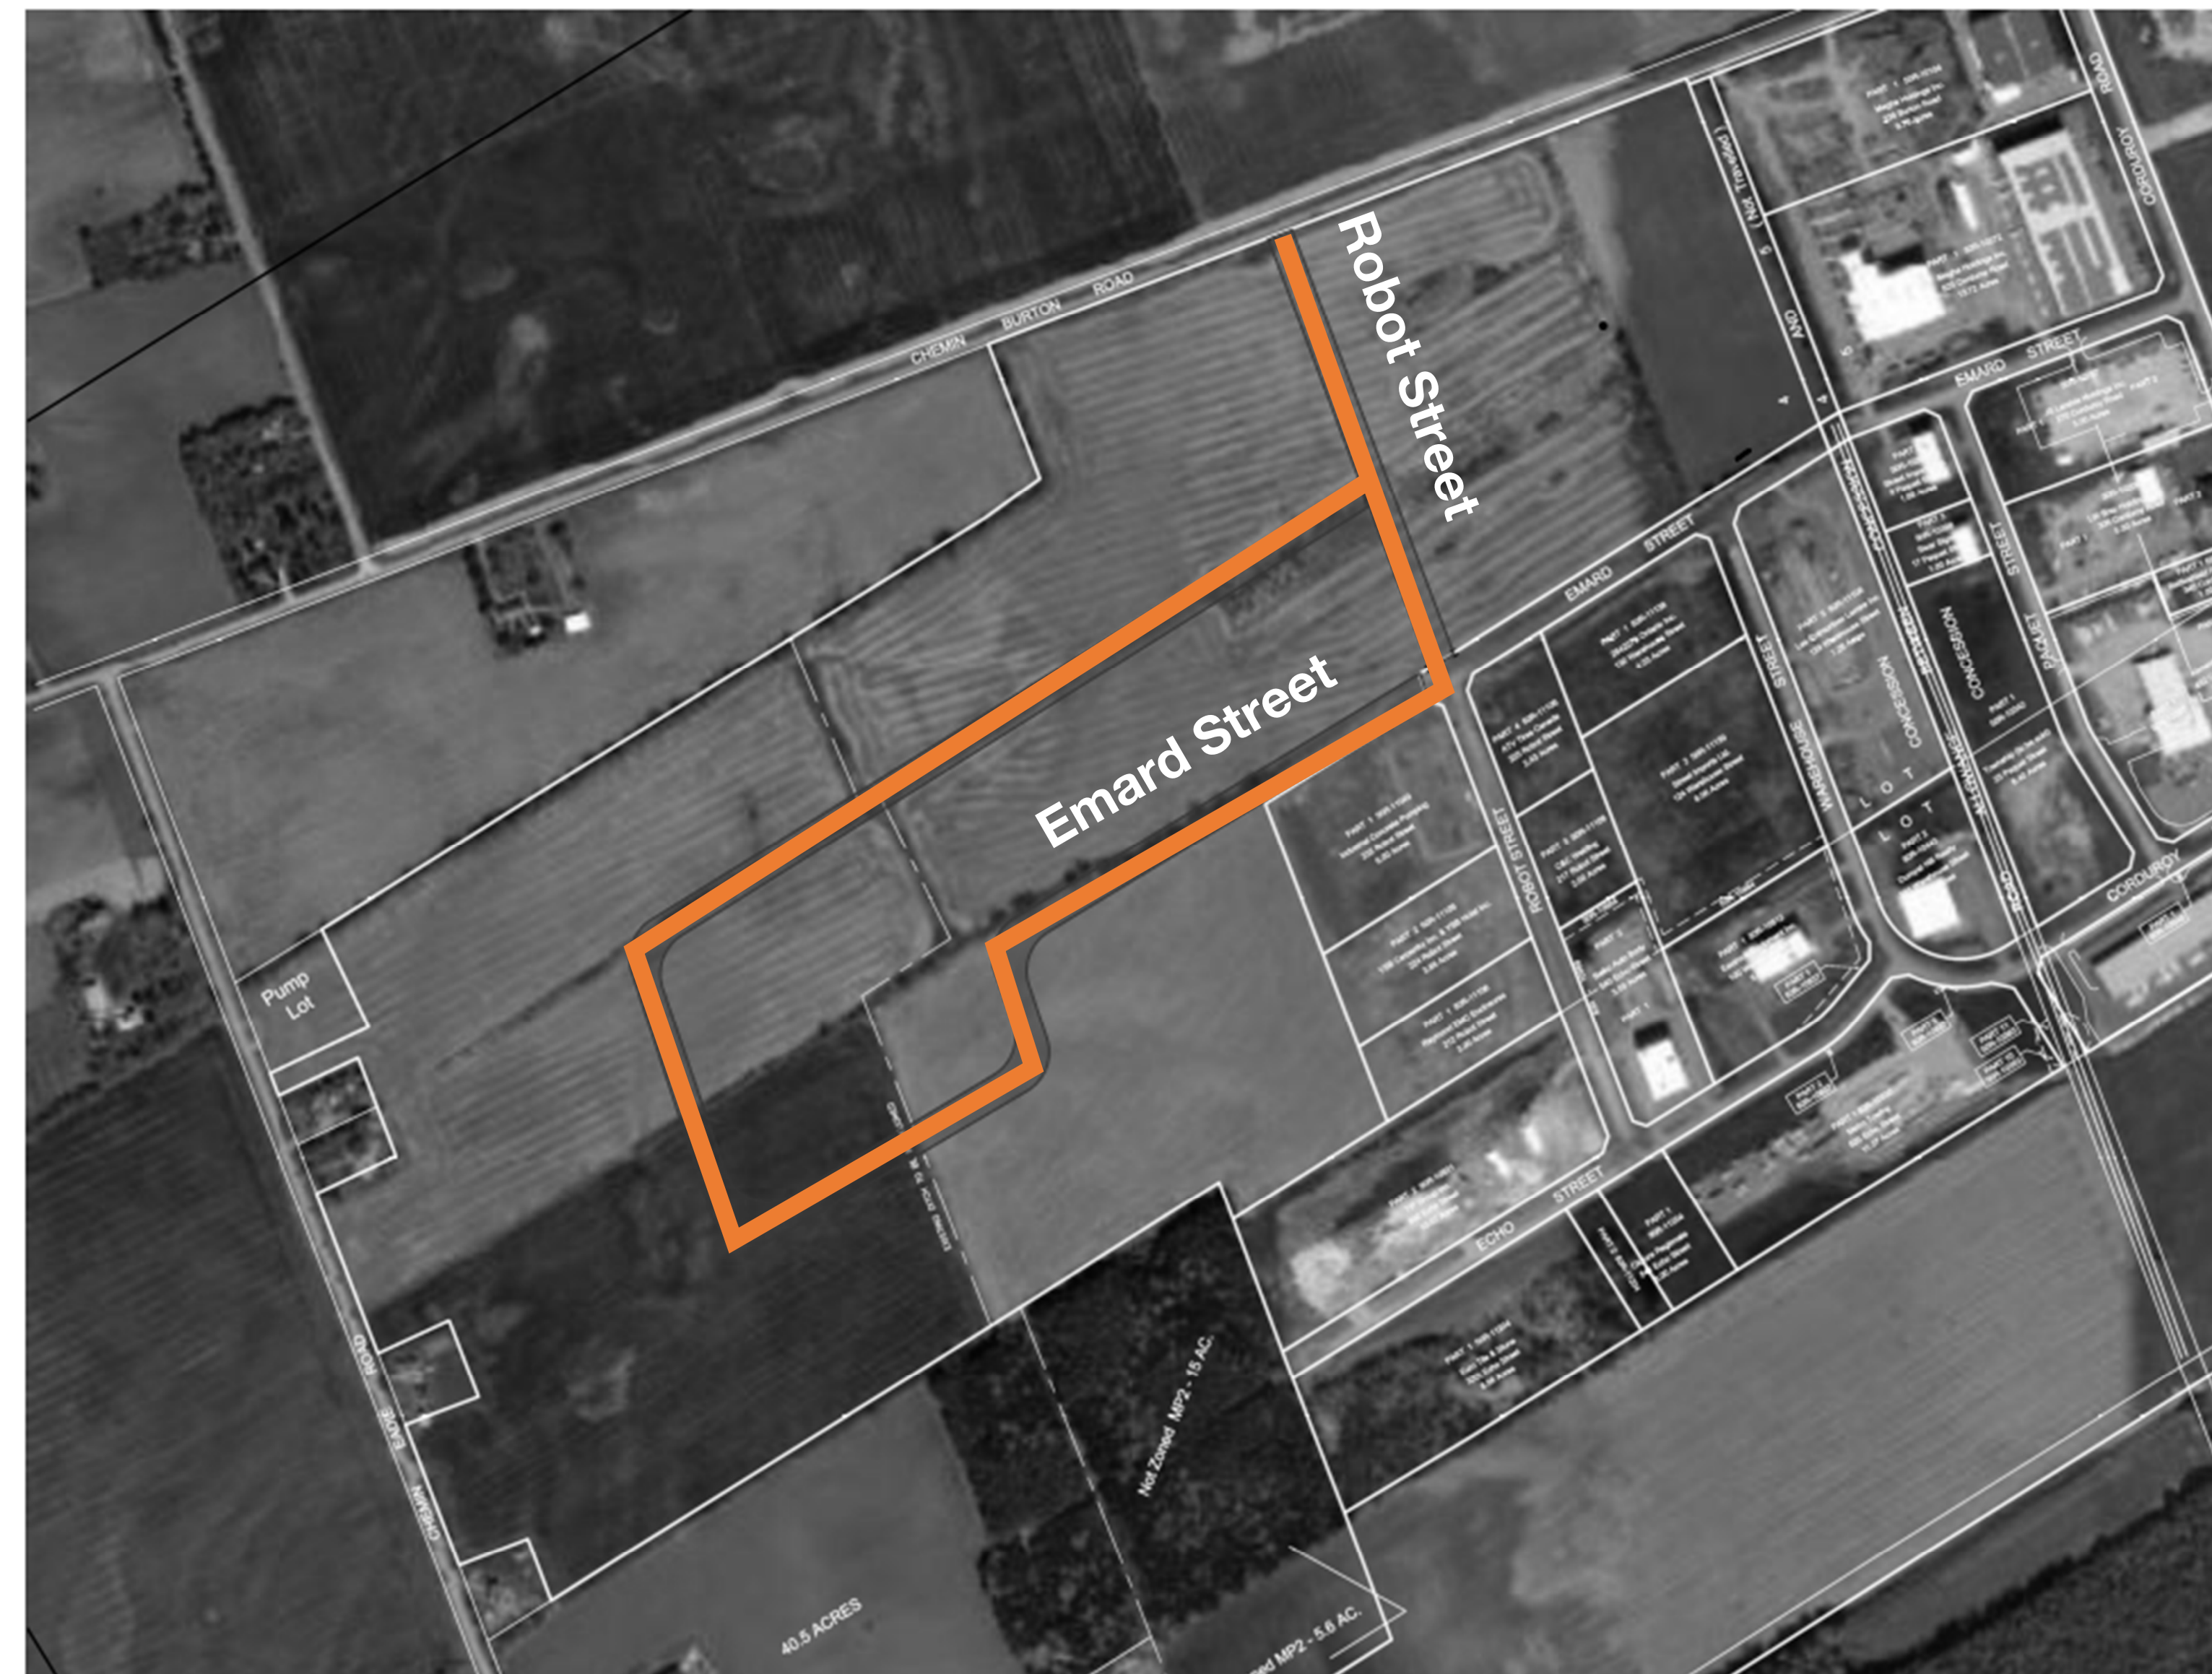
*Option 4: Extension of Robot Street, and extension of Emard Street to Cover Phase 3 and Future developments*

<b>Cost &amp; Constructability</b>	Constructability	Complex geometric road layout, difficulty for sewer and utility installation and drainage design.	1
	Construction Cost	Long road length results in greater construction costs for road.	1
<b>Total</b>			<b>18</b>

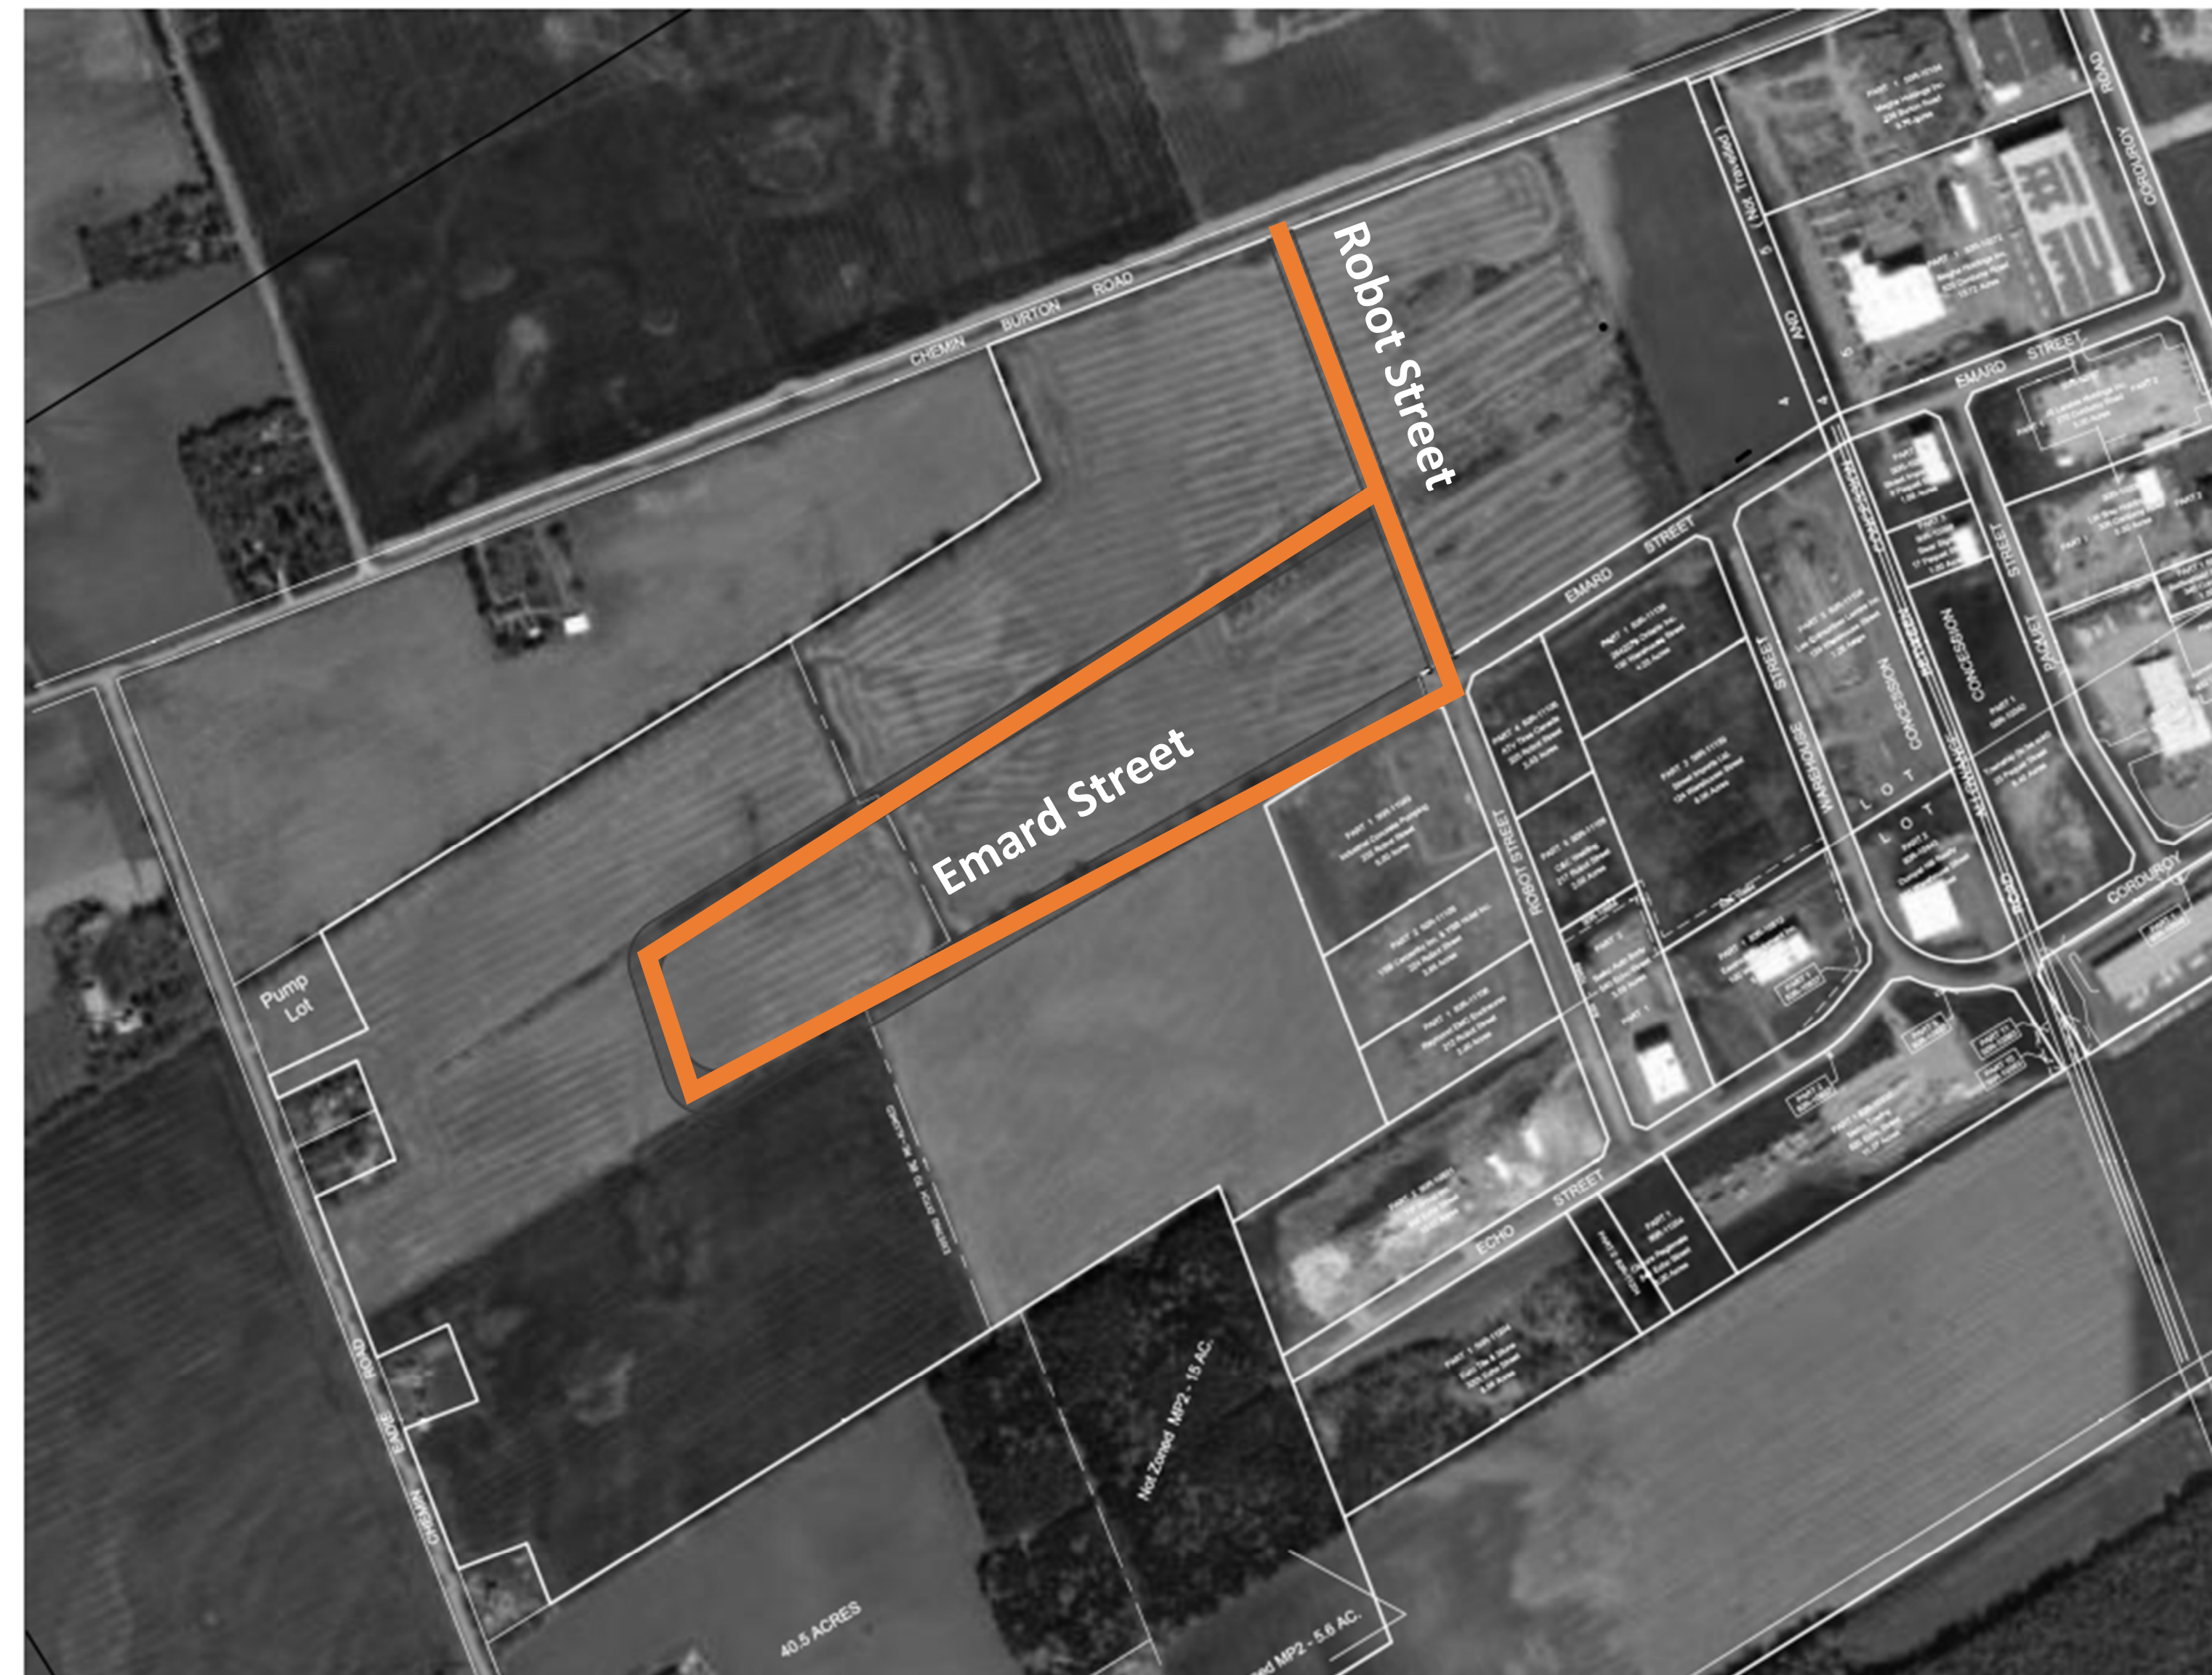
*Option 5: Extension of Robot Street, and extension of Emard Steet networking back to Robot*

<b>Cost &amp; Constructability</b>	Constructability	Moderate geometric road layout, some challenge for sewer and utility installation and drainage design.	2
	Construction Cost	Moderate road length results in greater construction costs for road.	2
<b>Total</b>			<b>23</b>

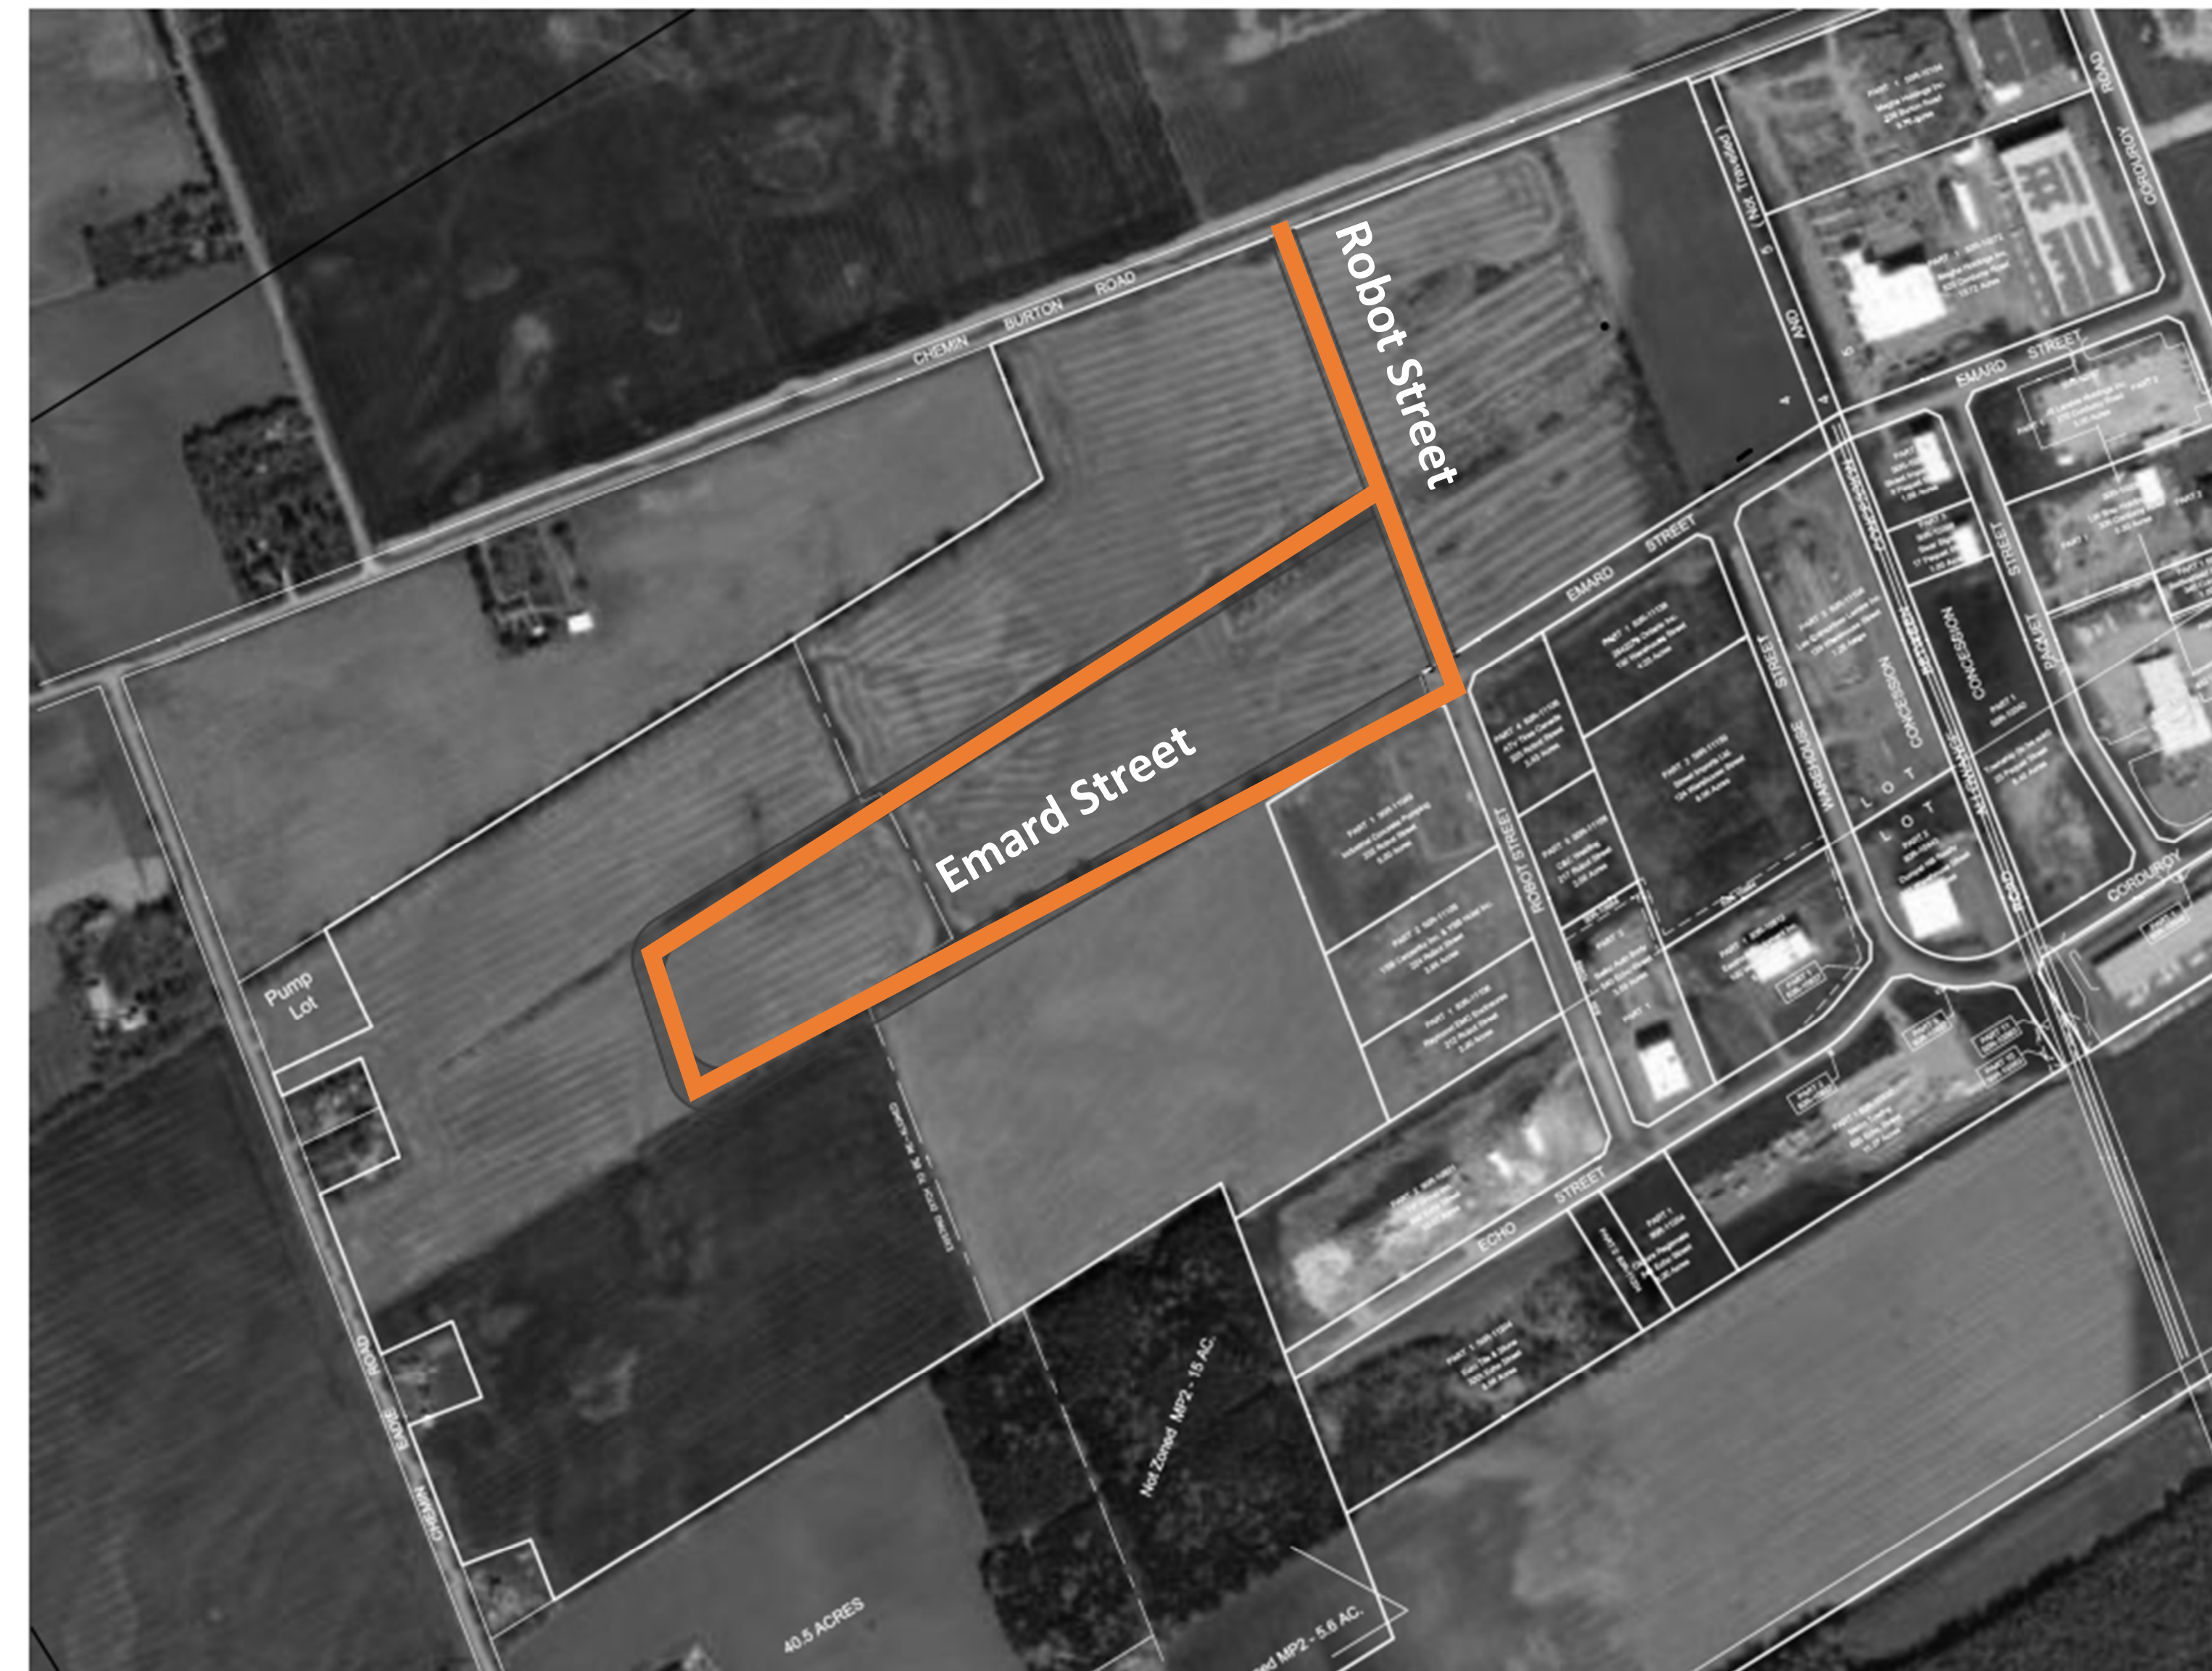
*Option 5: Extension de la rue Robot et bouclage de la rue Emard sur la rue Robot*

Critères	Contexte	Evaluation
<b>Aspects techniques</b>	Sécurité	Mauvaise connectivité. Nommbreux virages.	2
	Volume de circulation & distribution	Traffic intérieur diminué avec deux rues parallèles. Traffic accrue sur Robot et à l'intersection Robot/Burton.	3
	Connection	Permet un accès par Burton. Aucun accès à Eadie.	3
	Géométrie routière & drainage	Tracés plus compliqués. Additional consideration for drainage required for lots around west-most driveway.	2
<b>Aspects socio-économiques</b>	Impact sur les propriétés avoisinantes	Aucune intersection, ni dérangement sur Eadie.	5
	Impact archéologique	En cours d'évaluation	En cours d'évaluation
	Usage efficace des terrains	Réduction de la dimension des lots et des gros projets potentiels.	2
<b>Aspects environnementaux</b>	Impact sur l'environnement	La rue Emard intercepte un fossé municipal provenant de Eardie. La construction de la rue aura un impact modéré à élevé sur l'environnement.	2

<b>Coûts &amp; faisabilité</b>	Faisabilité	Géométrie compliquée. Difficultés anticipées pour la conception des services municipaux, des utilités et du drainage.	2
	Coûts de construction	Rues plus longues = coûts plus élevés	2
<b>Total</b>			<b>23</b>

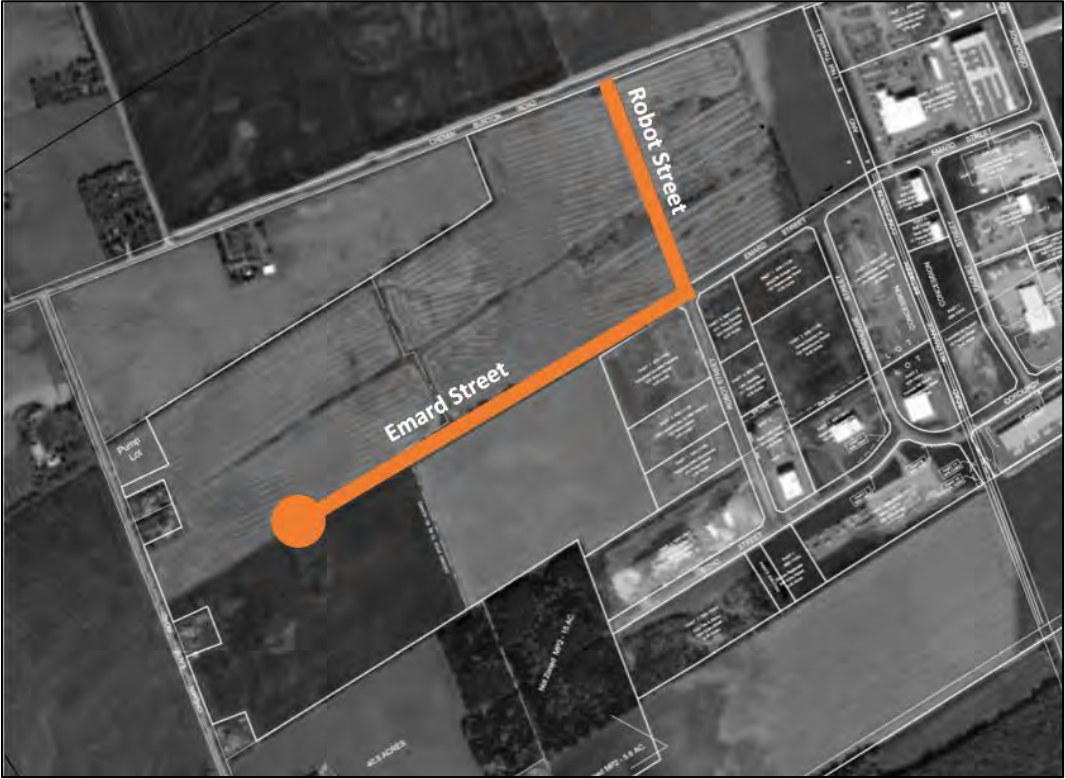
Access into the Industrial Park from Burton Road will extend between Emard Street and Burton Road aligned with the current right of way of Robot Street. Figure 1 below provides a Sketch of this alignment.

**Figure 1: Cul-de-sac at Emard Street and Extension of Robot Street**  
*(Presented as Option 3 at the Public Information Centre in May 2024)*

Rationale specifically related to the impact on the surrounding properties and internal park connectivity have impacted the evaluation of the potential alternatives for the alignment of the roadways. The updated preferred option proposes terminating the roadway extension of Emard Street with a cul-de-sac prior to reaching Eadie Road. This configuration will meet minimum requirements for emergency vehicle access as per NFPA (National Fire Protection Association) Standards and consider efficient snow removal practices for improved winter accessibility. Additionally, the cross-section design will reflect a rural cross-section with roadside ditches to manage stormwater and maintain a natural setting.

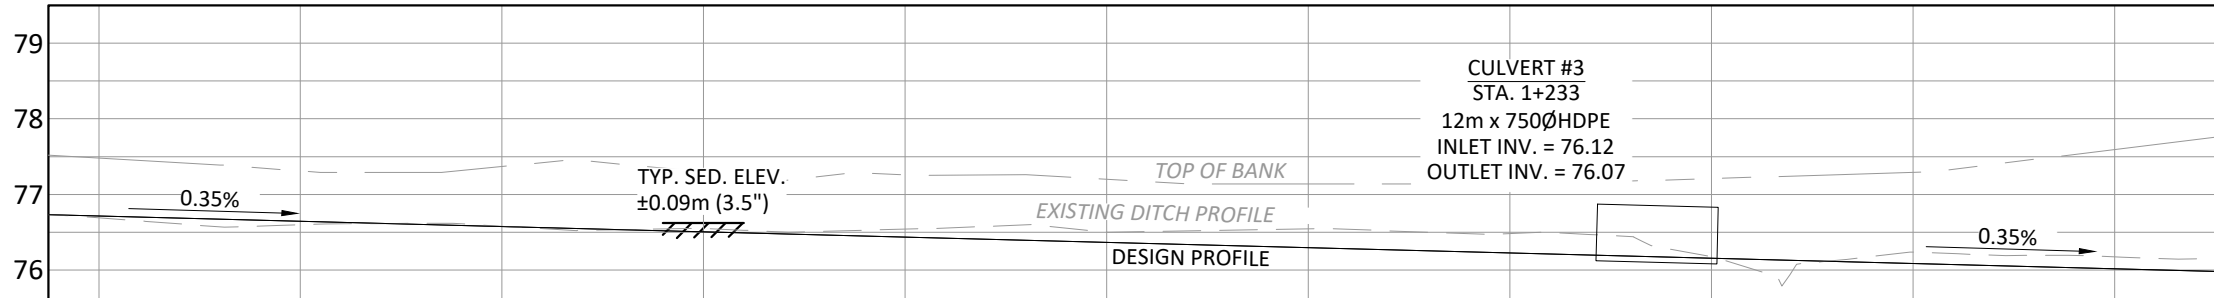
**WOOD-EADIE MAIN DRAIN  
PROFILE  
STA. 1+075 - 1+292**

ELEVATIONS	EX. GROUND PR. DITCH INV.	STATIONS
	76.69 / 76.72	1+080
	76.60 / 76.65	1+100
	76.58 / 76.58	1+120
	76.55 / 76.51	1+140
	76.54 / 76.44	1+160
	76.50 / 76.37	1+180
	76.55 / 76.30	1+200
	76.48 / 76.23	1+220
	76.18 / 76.16	1+240
	76.24 / 76.09	1+260
	76.17 / 76.02	1+280

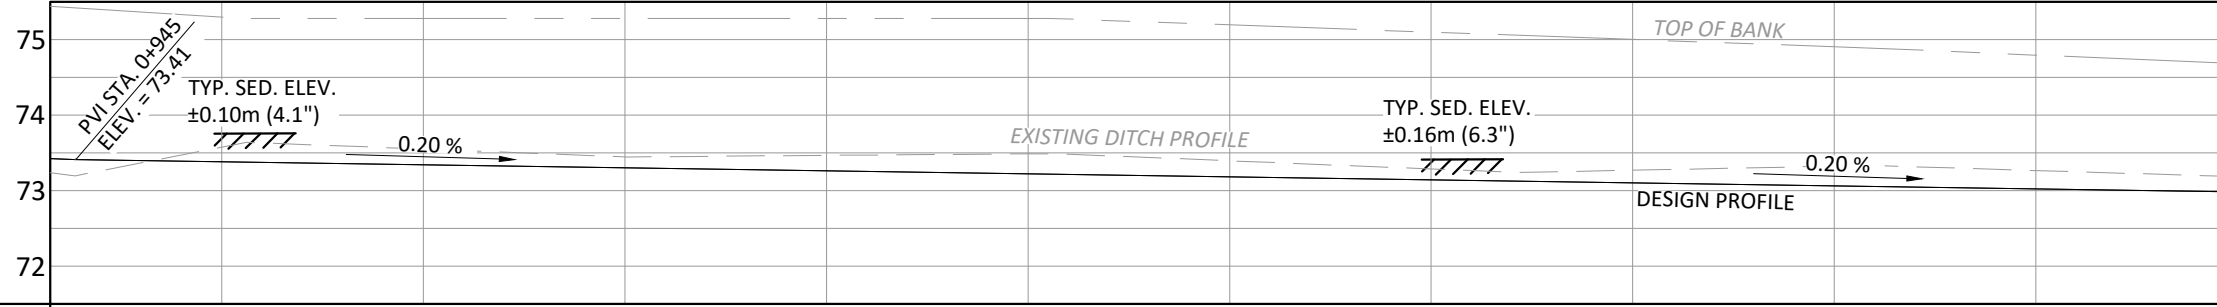
WOOD-EADIE MAIN DRAIN  
PROFILE  
STA. 1+943 - 2+160

ELEVATIONS	EX. GROUND PR. DITCH INV.	STATIONS
73.58 73.38	73.55 73.34	1+960
73.45 73.30	73.47 73.26	1+980
73.49 73.22	73.40 73.18	2+000
73.29 73.14	73.27 73.10	2+020
73.32 73.06	73.27 73.02	2+040
		2+060
		2+080
		2+100
		2+120
		2+140

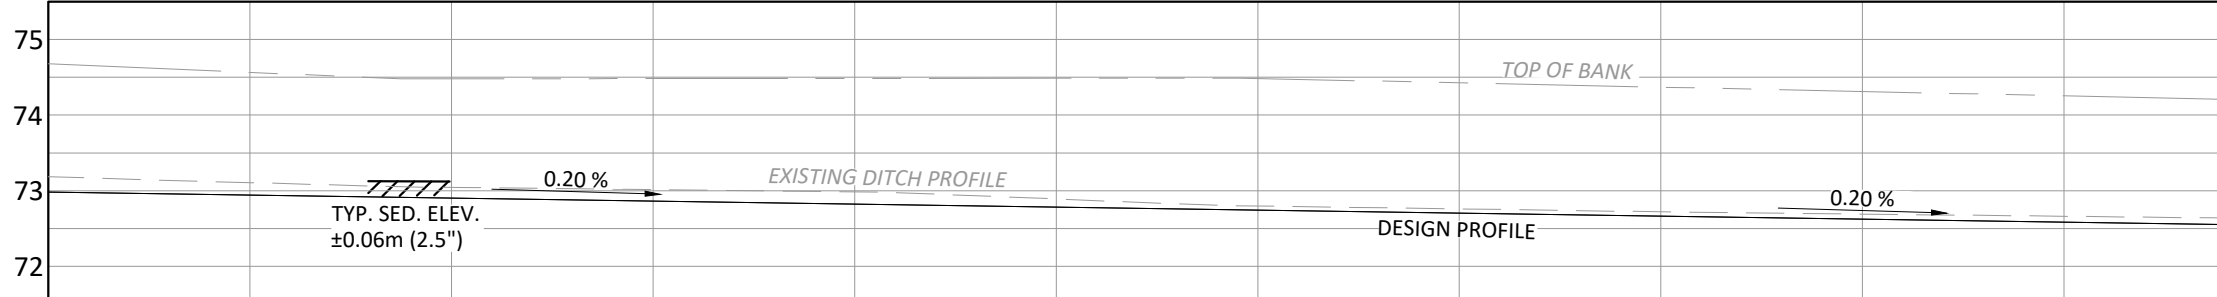
WOOD-EADIE MAIN DRAIN  
PROFILE  
STA. 2+160 - 2+377

ELEVATIONS	EX. GROUND PR. DITCH INV.	STATIONS
73.11 72.94	73.04 72.90	2+180
73.01 72.86	72.98 72.82	2+200
72.89 72.78	72.80 72.74	2+220
72.76 72.70	72.72 72.66	2+240
72.69 72.62	72.66 72.58	2+260
		2+280
		2+300
		2+320
		2+340
		2+360

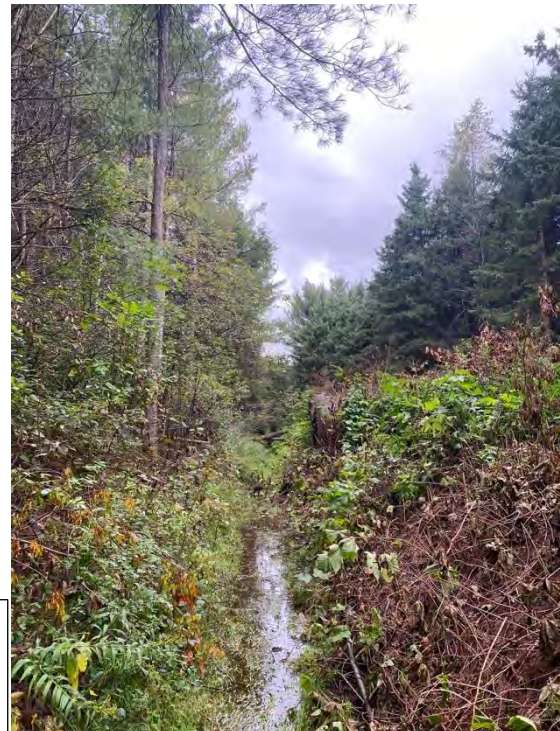
The north section of the drain flowed through a white spruce (*Picea glauca*) plantation. Vegetation species observed within this area included: white spruce, large-toothed aspen (*Populus grandidentata*), glossy buckthorn (*Rhamnus frangula*), grey dogwood (*Cornus racemosa*), black elderberry (*Sambucus nigra*), purple-flowering raspberry (*Rubus odoratus*), sensitive fern (*Onoclea sensibilis*), and jewelweed (*Impatiens capensis*).

Photo 1: North section of Wood Eadie Municipal Drain, facing north, September 10, 2023.

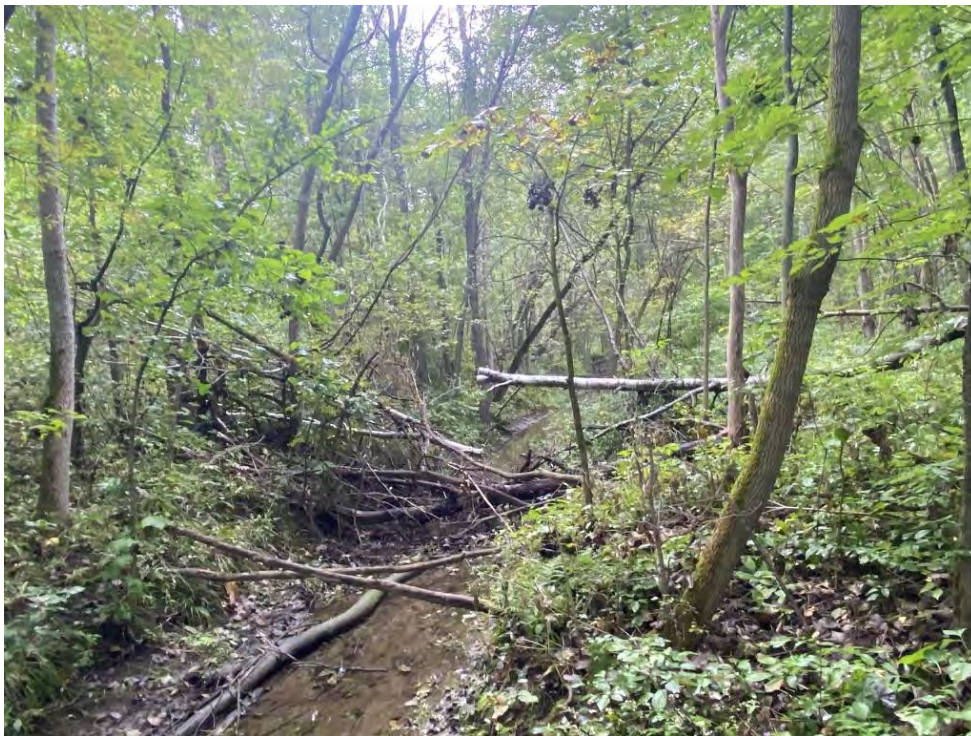
The south section of the drain flowed through a heavily vegetated moist deciduous forest. The following vegetation species were observed within this area: red maple (*Acer rubra*), American elm (*Ulmus americanum*), trembling aspen (*Populus tremuloides*), black cherry (*Prunus serotina*), green ash (*Fraxinus pennsylvanica*), basswood (*Tilia americana*), white birch (*Betula papyrifera*), red osier dogwood (*Cornus sericea*), glossy buckthorn, black elderberry, red raspberry (*Rubus idaeus*), gooseberry sp. (*Ribes* sp.), poison ivy (*Toxicodendron radicans*), Virgin's bower (*Clematis virginiana*), Virginia creeper (*Parthenocissus quinquefolia*), ostrich fern (*Matteuccia struthiopteris*), sensitive fern, stinging nettle (*Urtica dioica*), common burdock (*Arctium minus*), enchanter's nightshade (*Circaea lutetiana*), foam flower (*Tiarella cordifolia*), goldenrod sp. (*Solidago* sp.), jewelweed, snakeroot (*Ageratina altissima*), Canada anemone (*Anemonastrum canadense*), avens sp. (*Geum* sp.), aster sp. (*Asteraceae* sp.), and Joe-pye weed (*Eutrochium purpureum*).

Photo 2: South section of Wood Eadie Municipal Drain, facing southeast, September 10, 2023.

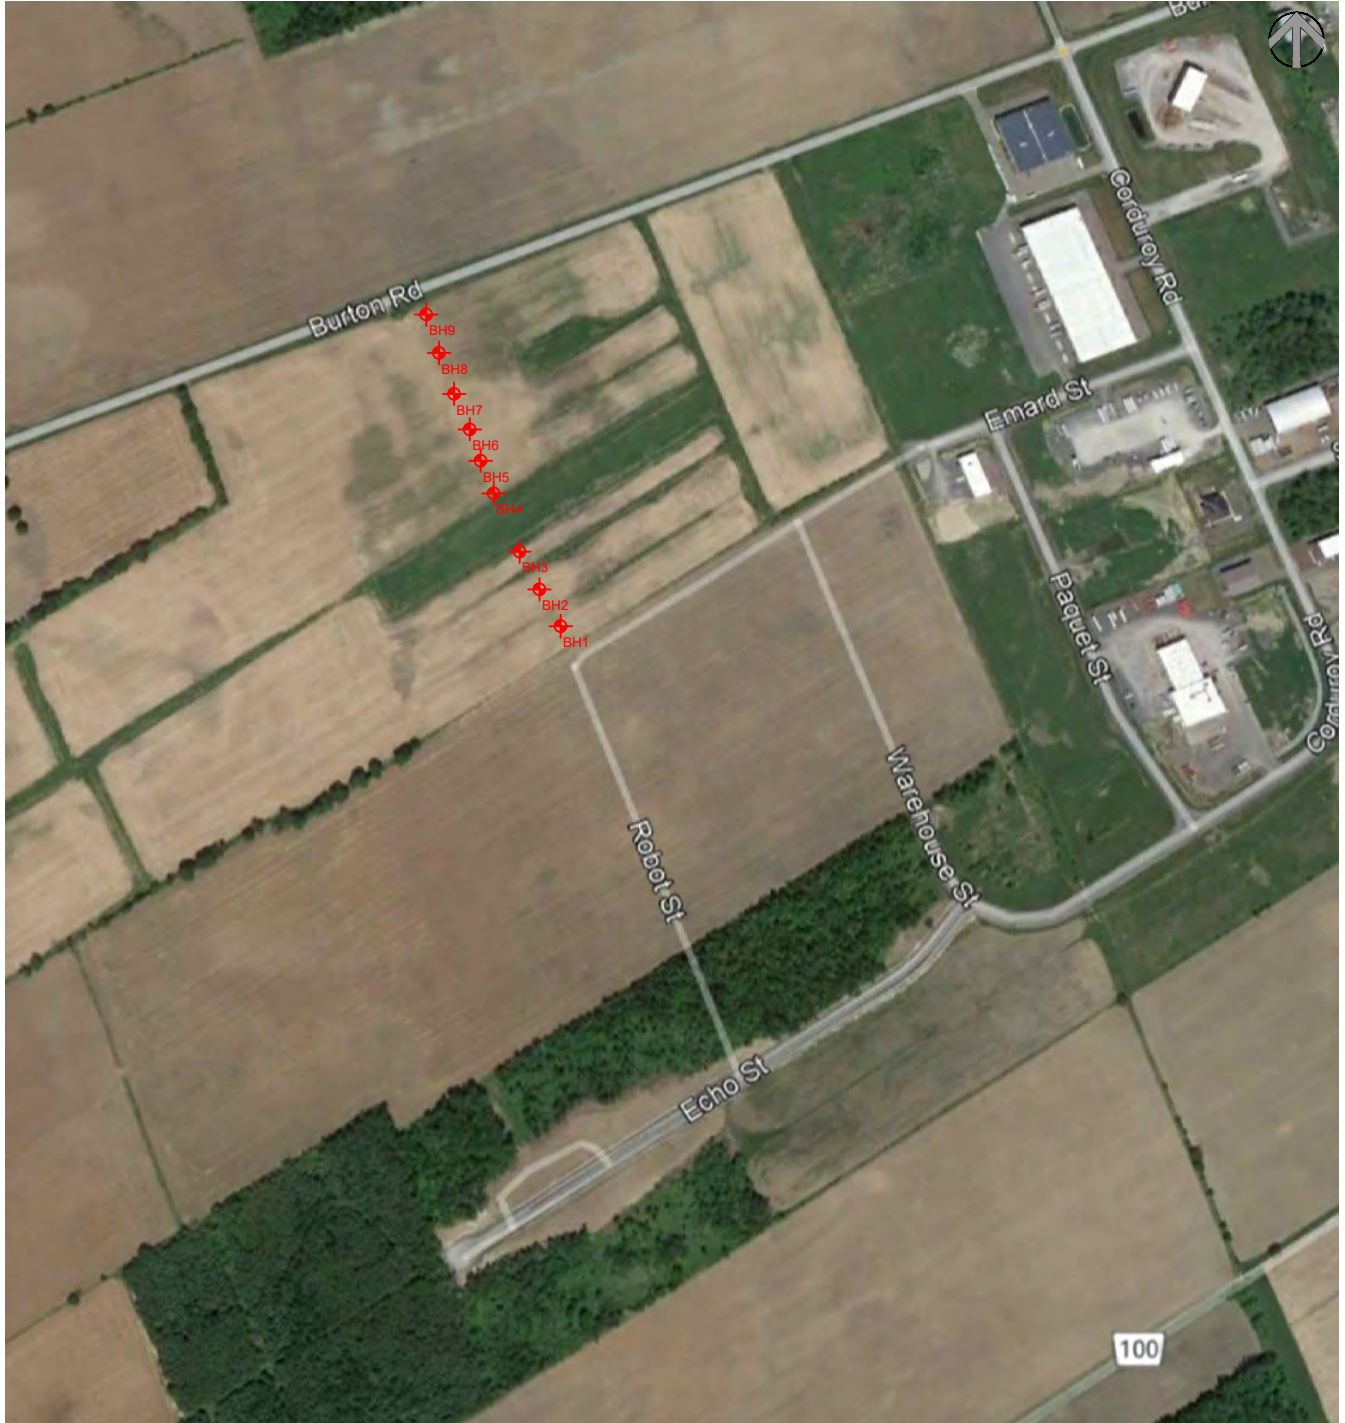
**FIGURE 2**

**APPENDIX A**  
**Site and Borehole Location Plan**

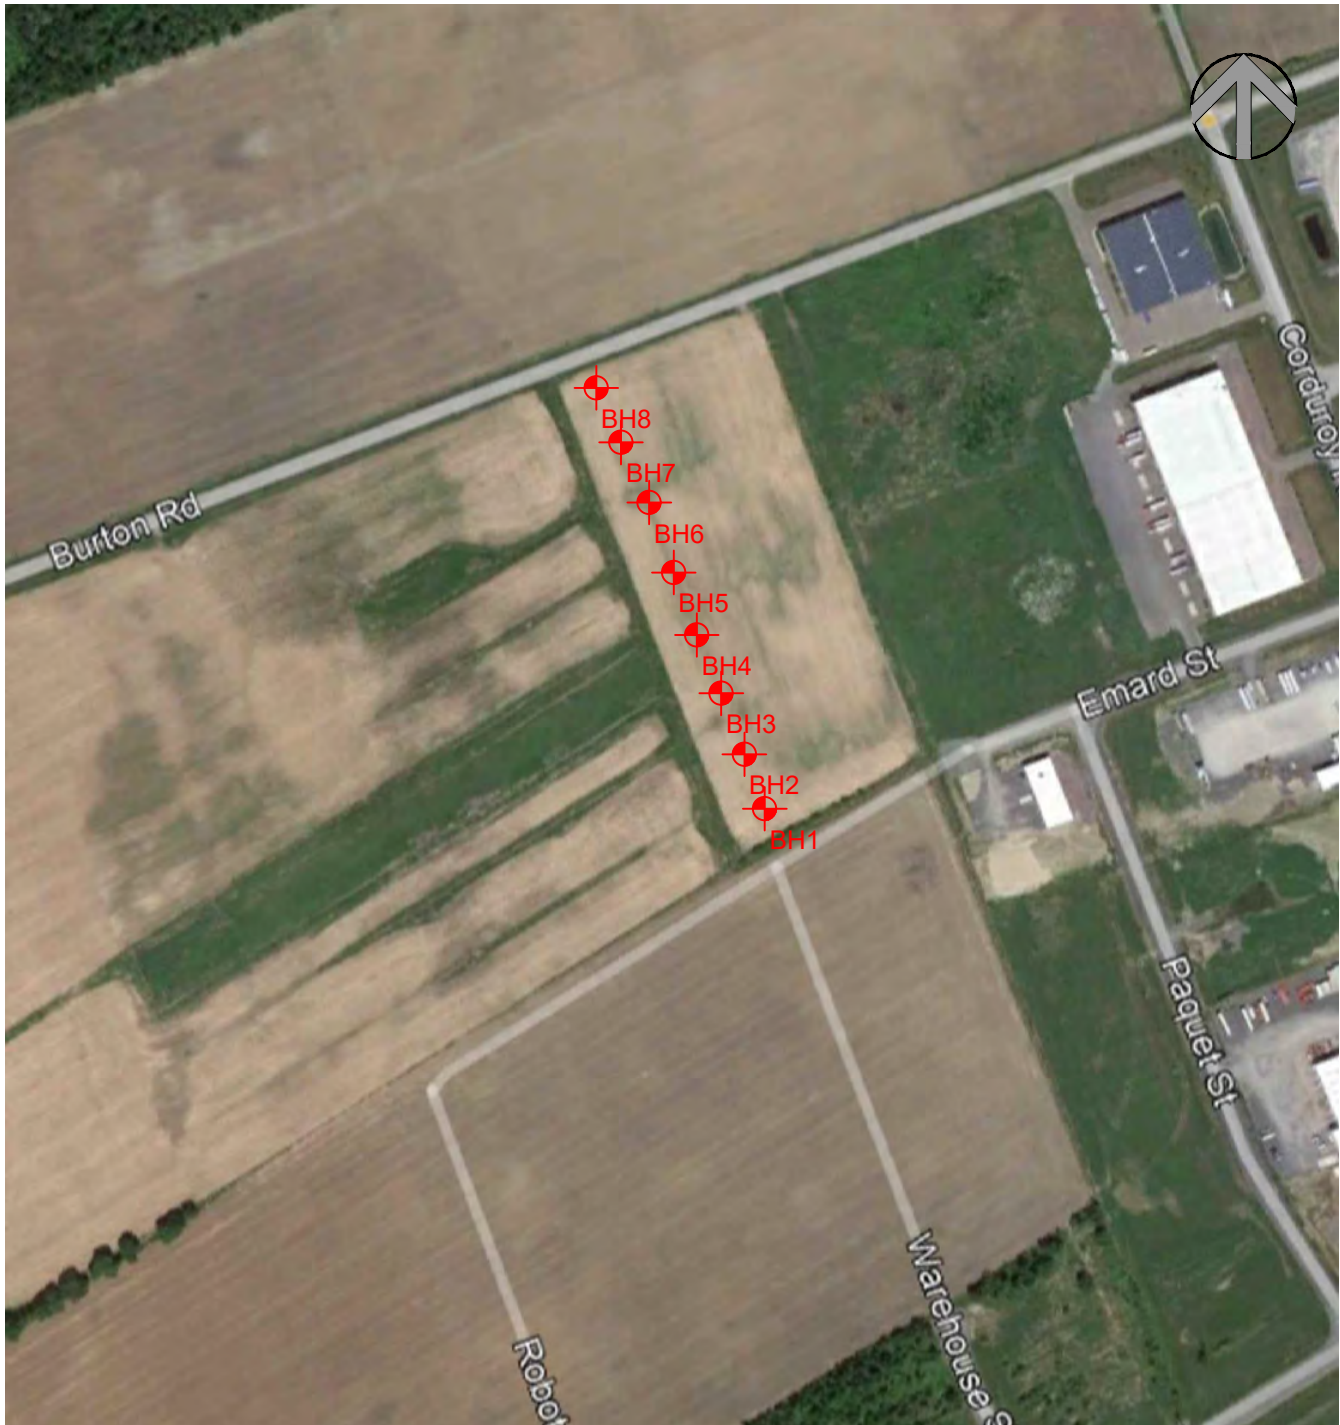
**FIGURE 2A**

**APPENDIX A**  
**Site and Borehole Location Plan**
