## **Municipal Class Environmental Assessment – Schedule B**

### **Project File Report**

Road Network Expansion  
417 Industrial Park, Township of Russell ON

LRL File No.: 230216.00  
Project No.: C0821-22048

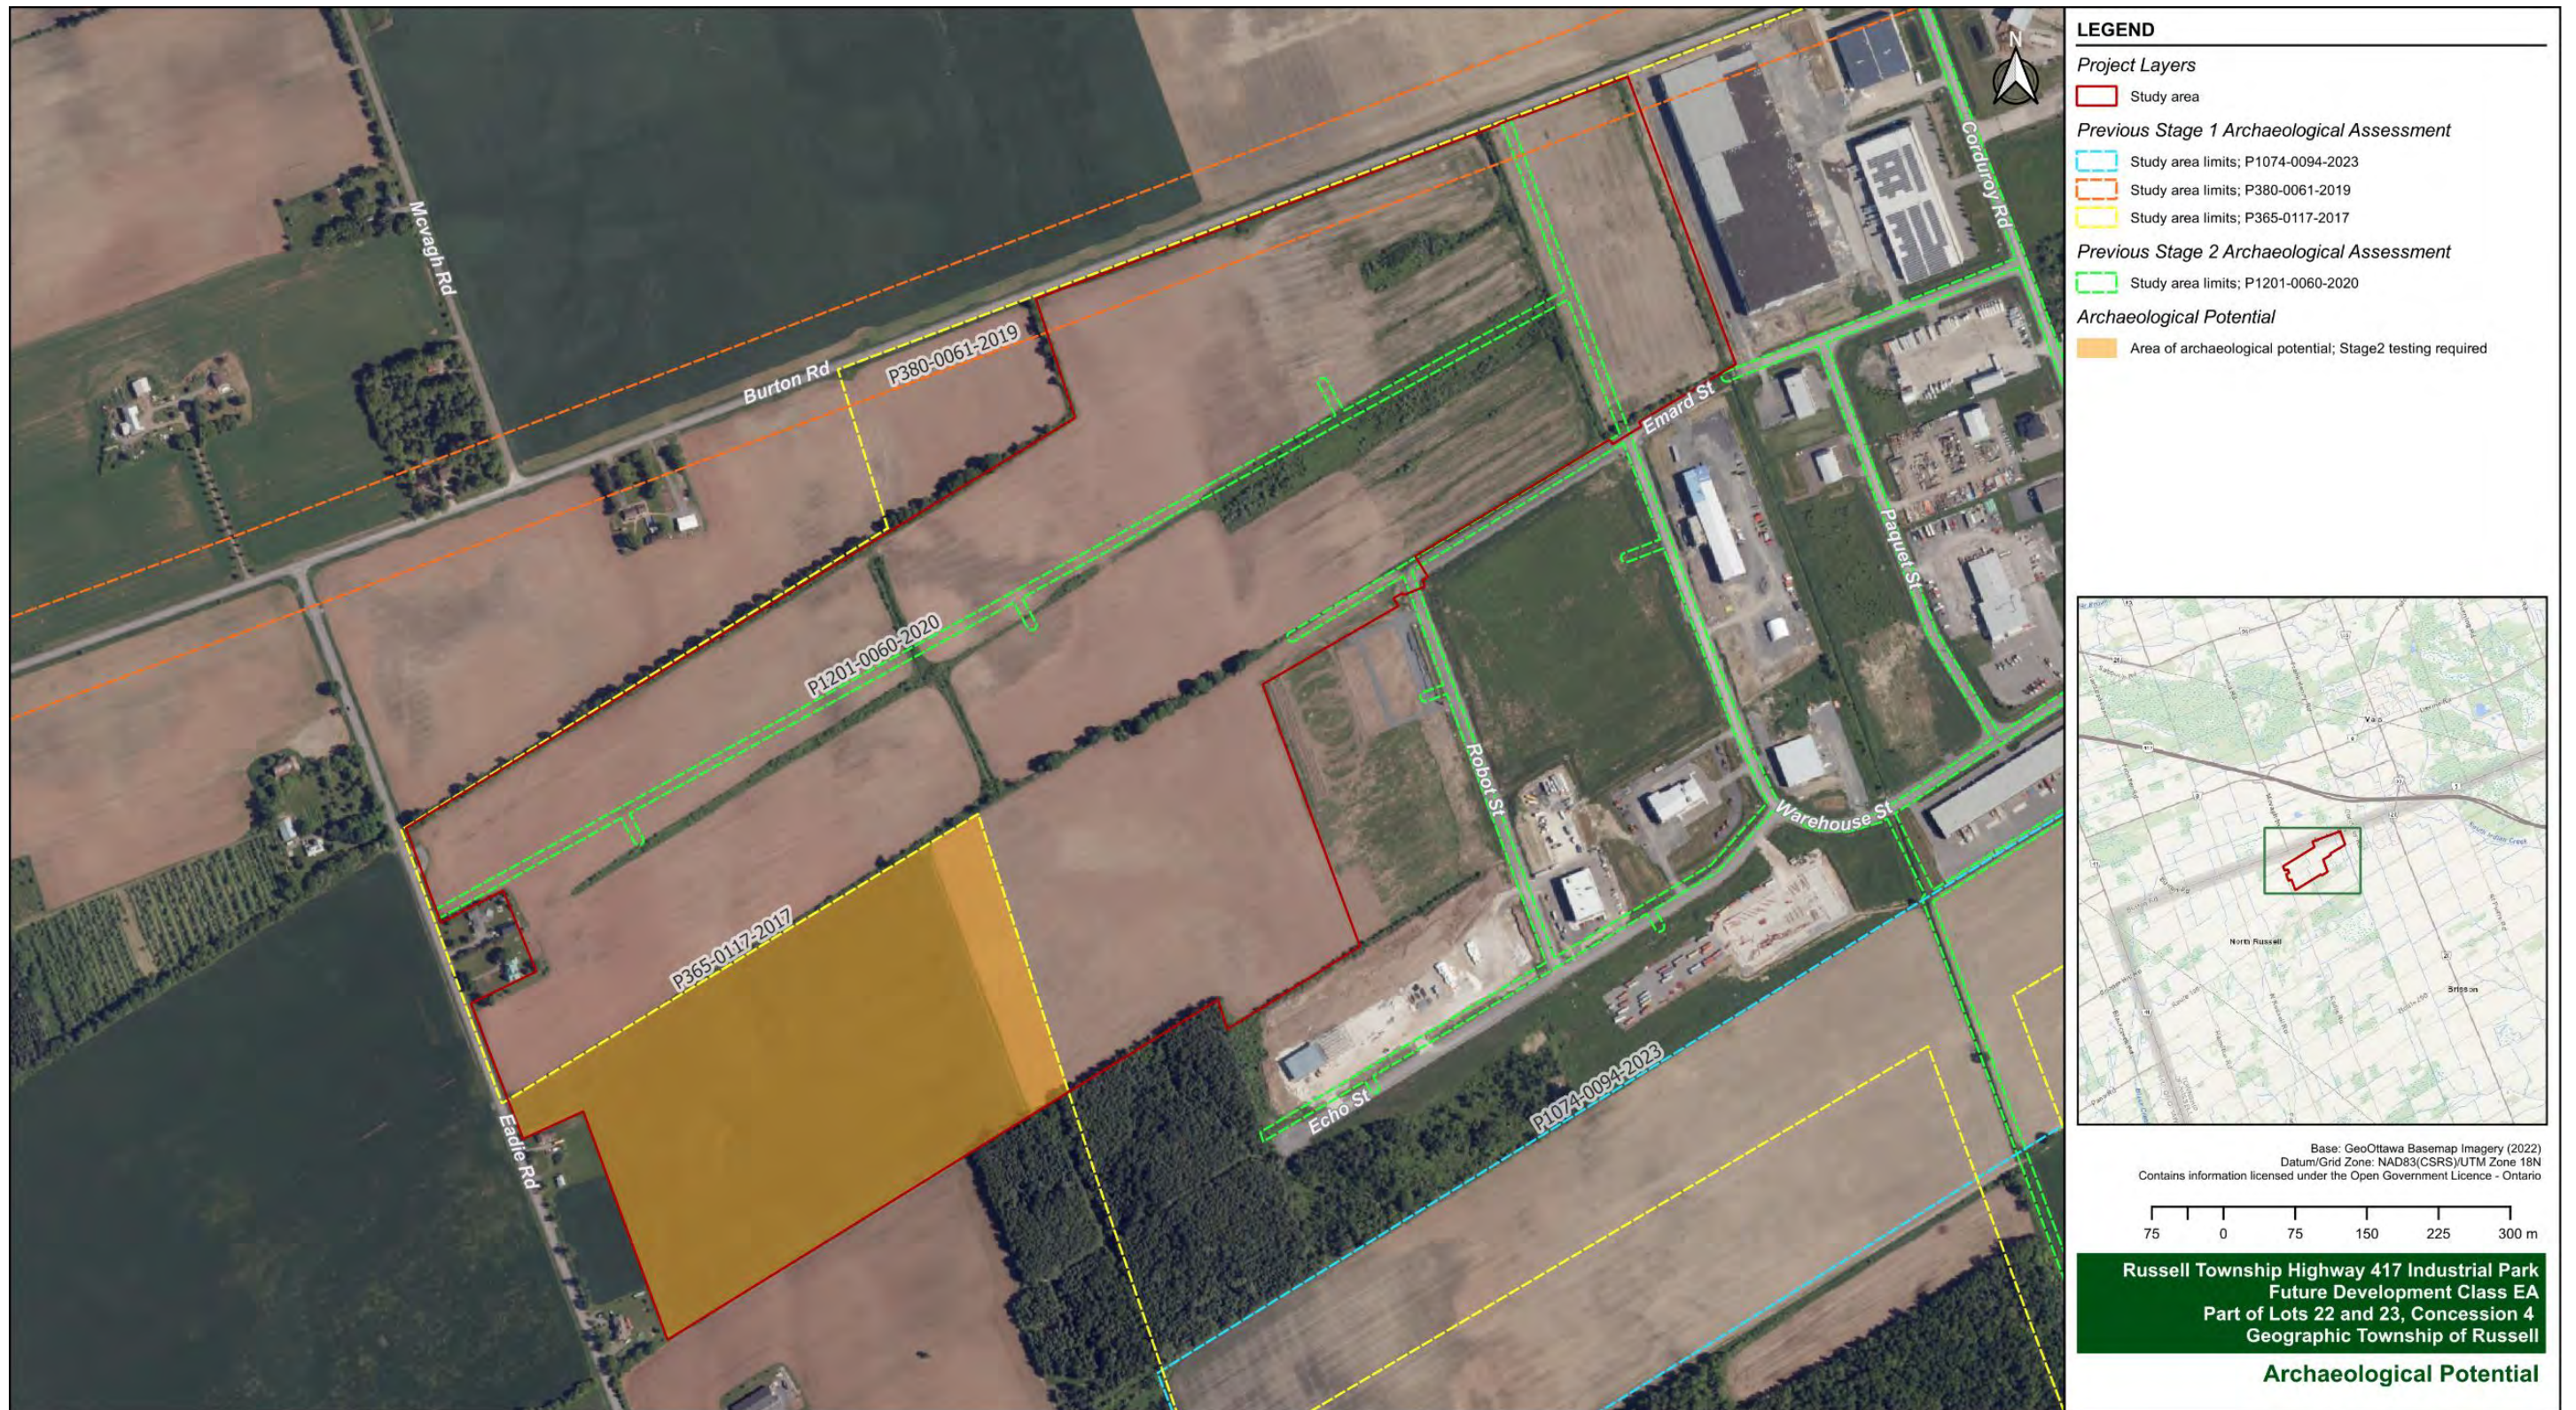
Map 7. Recent (2022) orthographic imagery showing areas of archaeological potential within the portion of the study area requiring Stage 1 assessment.

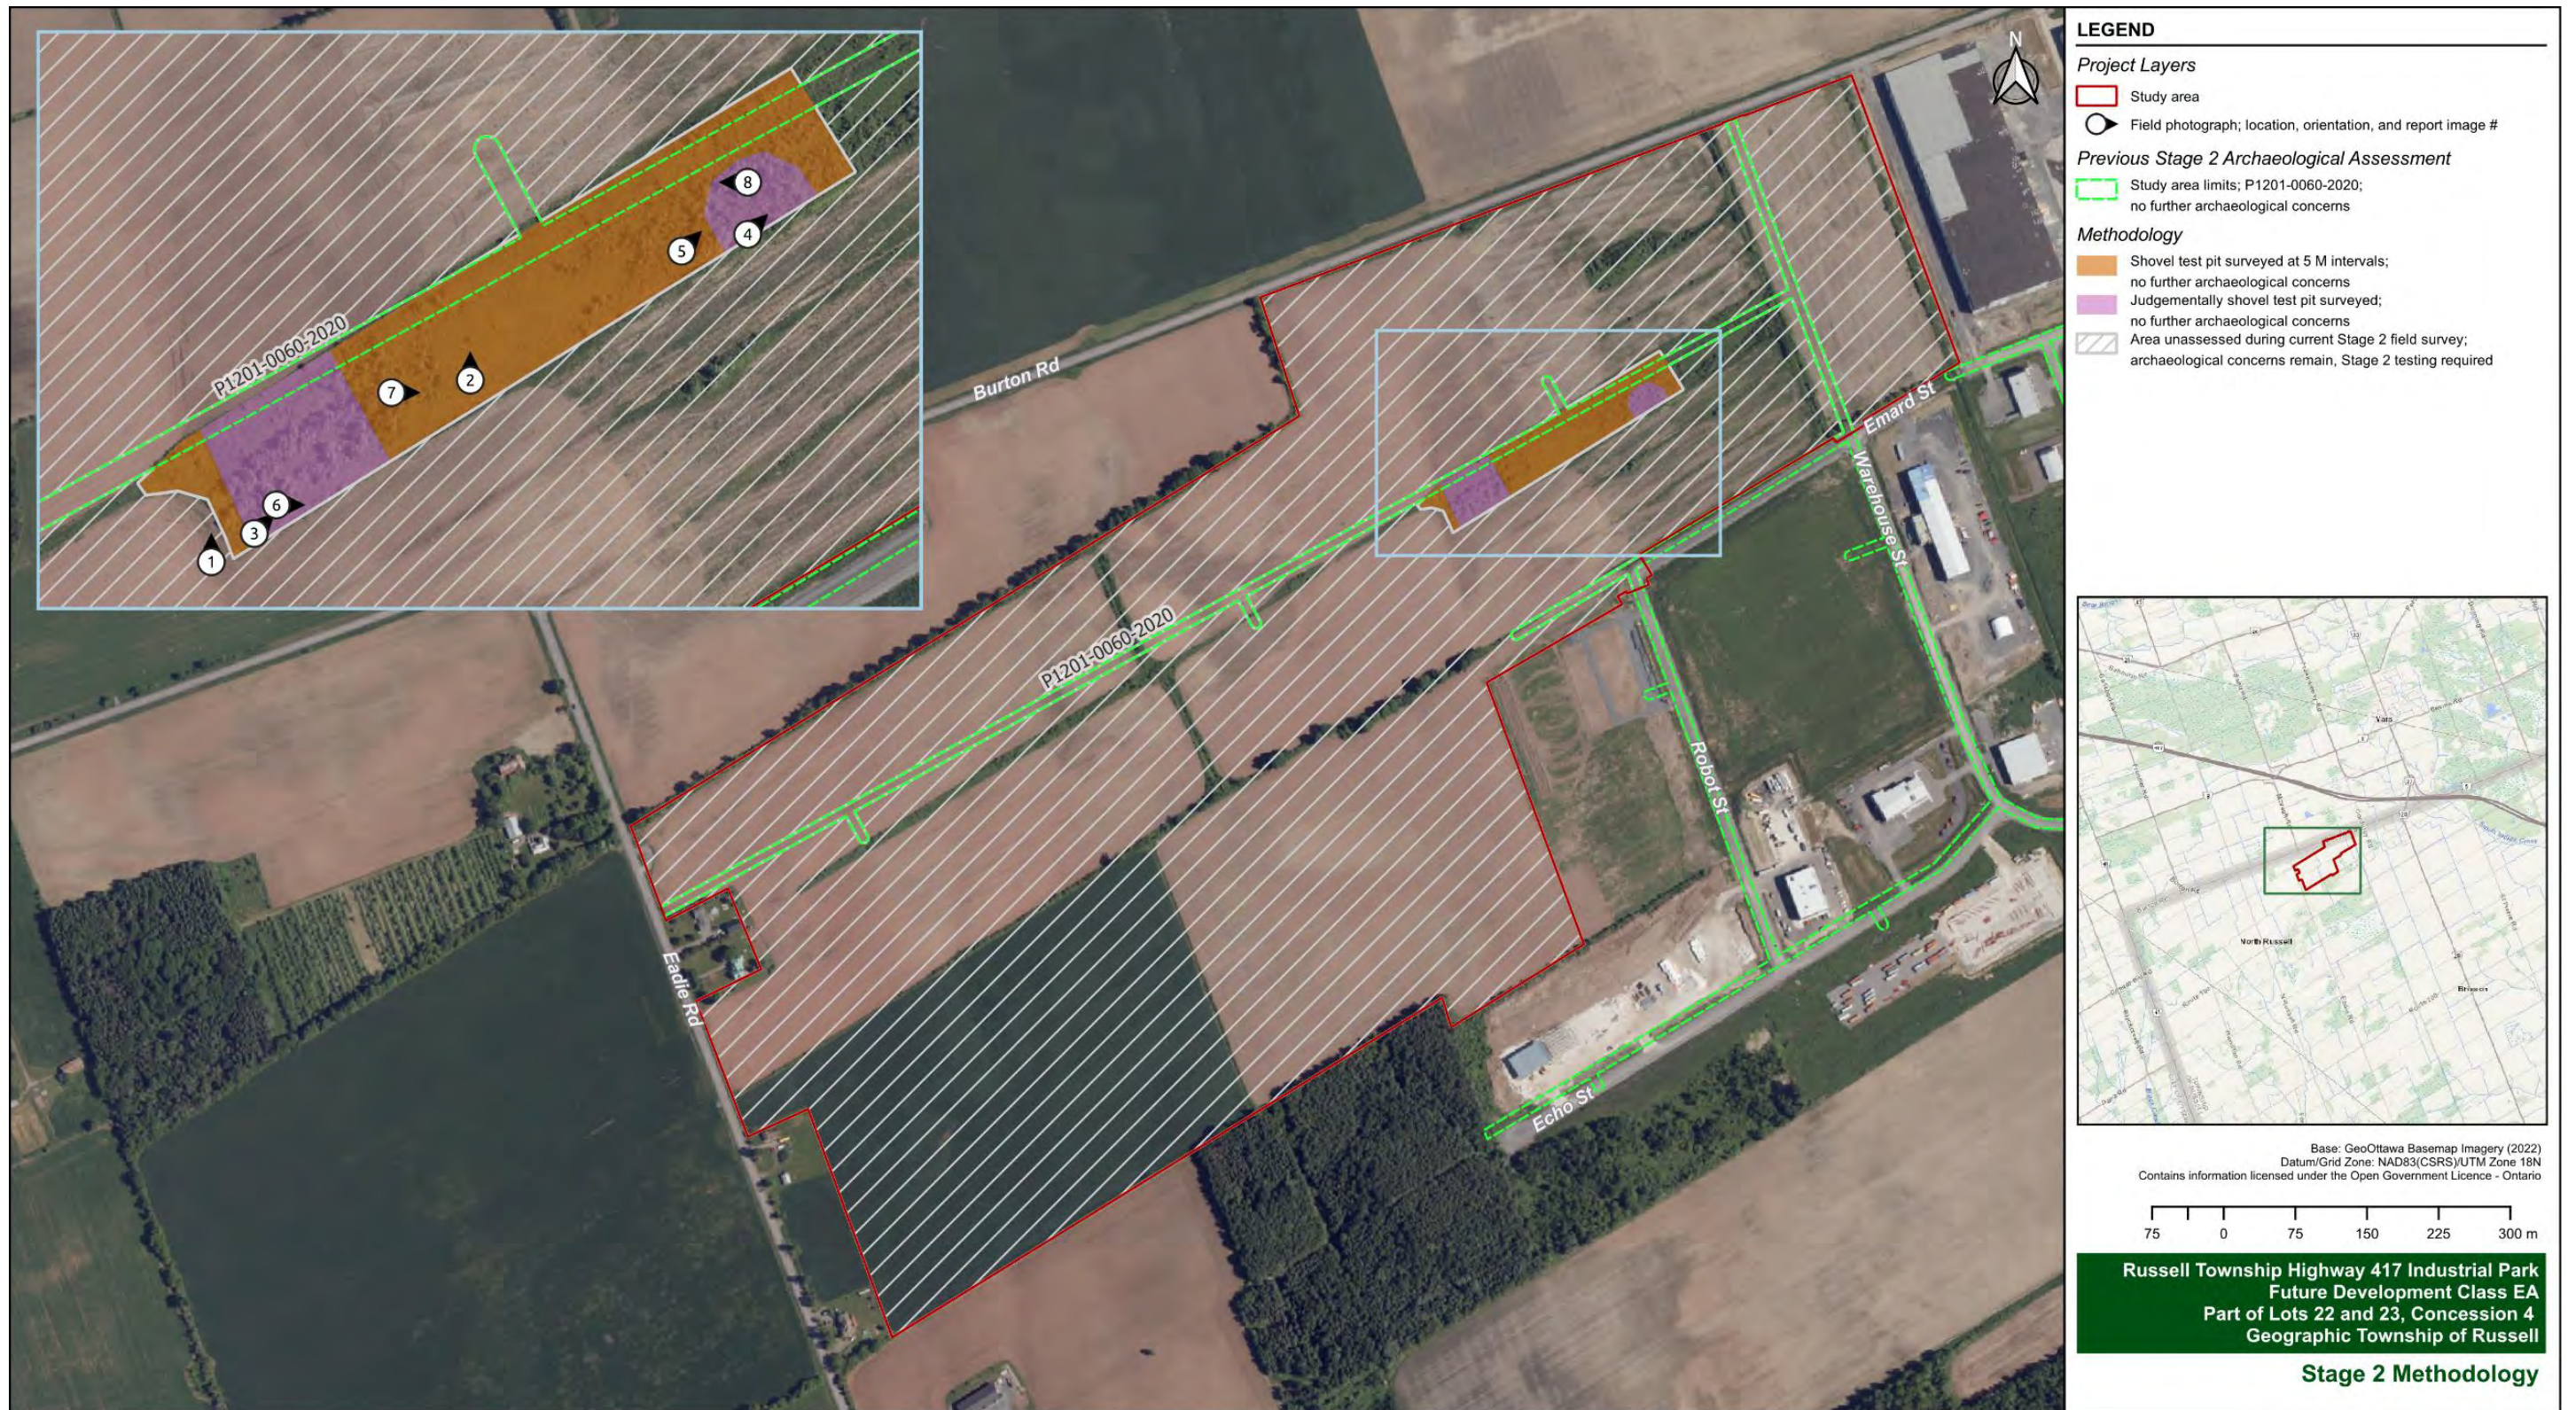
Map 8. Recent (2022) orthographic imagery showing Stage 2 field methods and results, as well as field photograph locations, orientation and image numbers.

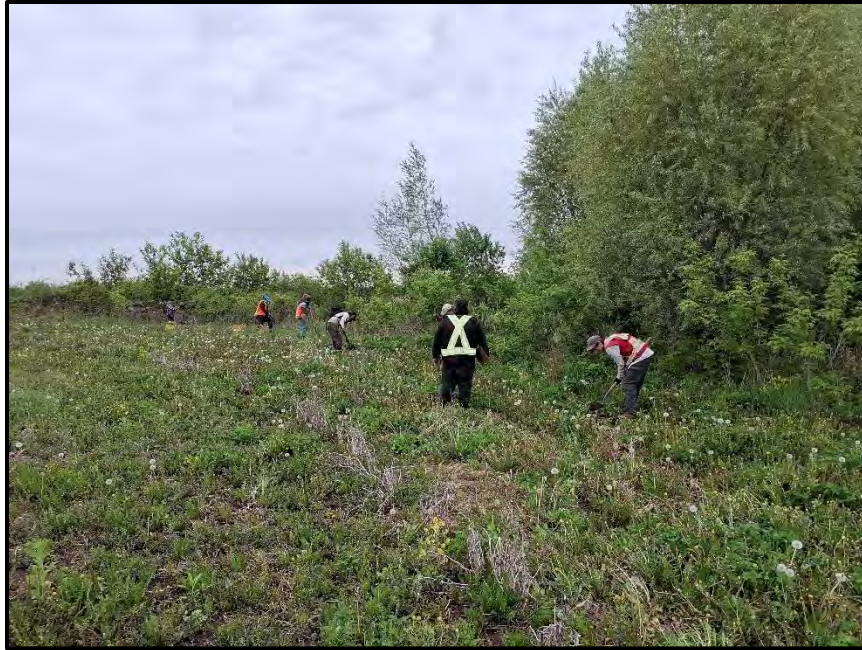
Image 1. View of field crew excavating at 5 m intervals, facing north. (PR24-007D002)

All test pit survey was completed using shovels and trowels, with back-dirt screened through 6 mm hardware mesh (Images 1 and 2). Shovel test pits were at least 30 cm in diameter and excavation continued for 5 cm into sterile subsoil. All pits were examined for soil stratigraphy, cultural features, and/or evidence of deep and intensive disturbance. Sample test pits were documented with digital photographs and field notes. Once all required recording had been completed, all test pits were backfilled. Soil layers within test pits were assigned lot numbers in the order of appearance. Low-lying areas with standing water or permanently saturated soils were typically encountered at the west end of the area tested (Image 3). The central portion of the area tested was typically dry, but the east end consisted of a mixture of wet and dry soils, and push-piles of bulldozed disturbed soil were also more frequent in this area (Images 4 and 5). As no archaeological resources were found, no test pit intensification was undertaken.

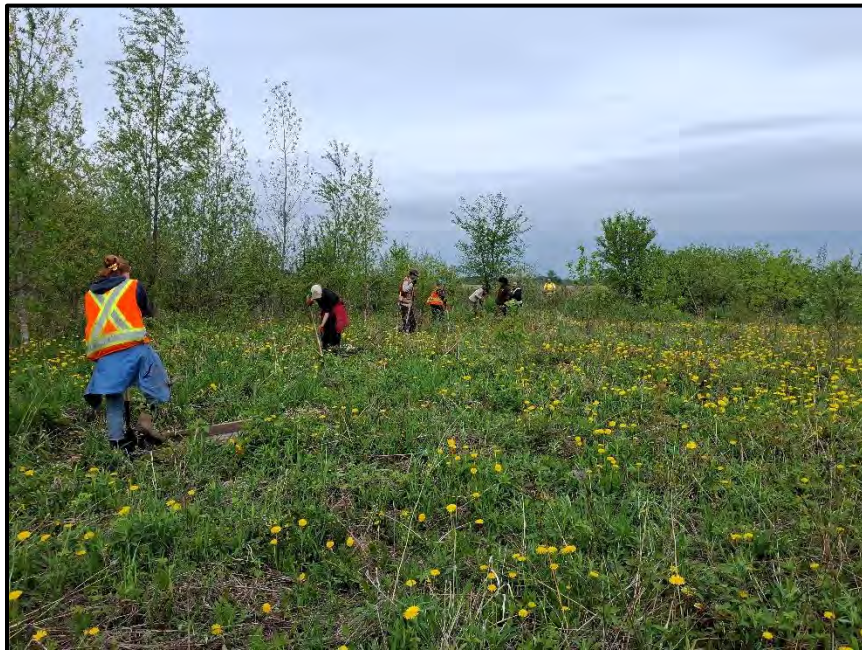
Image 2. View of field crew excavating at 5 m intervals, facing north. (PR24-007-025)

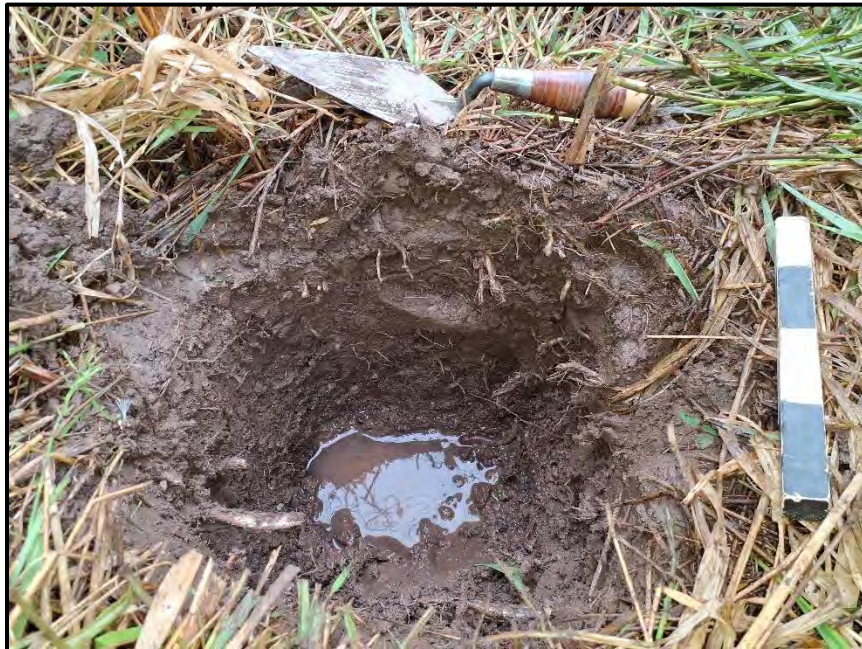
**Image 6. Sample test showing an undisturbed soil profile but with water saturation, facing east. (PR24-007D006)**

The soil stratigraphy was generally comprised of 23 cm to 40 cm of brown to dark brown silty clay topsoil. In the western end of the tested area the topsoil was typically underlain by pale brown or orange-brown clay subsoil, which then filled quickly with water (Image 6). In the central section the topsoil was typically underlain by black or very dark brown clay loam buried wetland matrix which was 12 cm to 15 cm thick (Image 7). This was in turn underlain by pale beige silt C-horizon subsoil. Typically, these test pits remained dry. Toward the eastern end the topsoil was either underlain by the buried wetland matrix which then gave way to light brown silty sand or pale beige silt subsoil, or underlain directly by subsoil (Image 8). Some of these test pits were water saturated. The soil stratigraphy encountered suggests that the lower topography to the east of the area shovel tested was previously a wetland or marsh and that the topsoil in the surrounding area had been used as fill to level out the agricultural field.

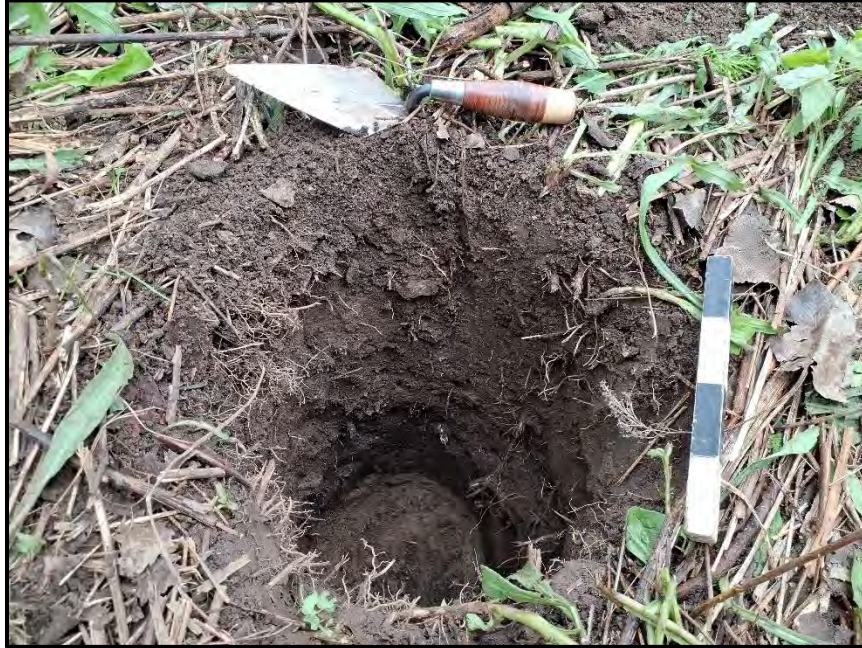
Image 7. Sample test pit showing an undisturbed soil profile, facing east. (PR24-007D018)

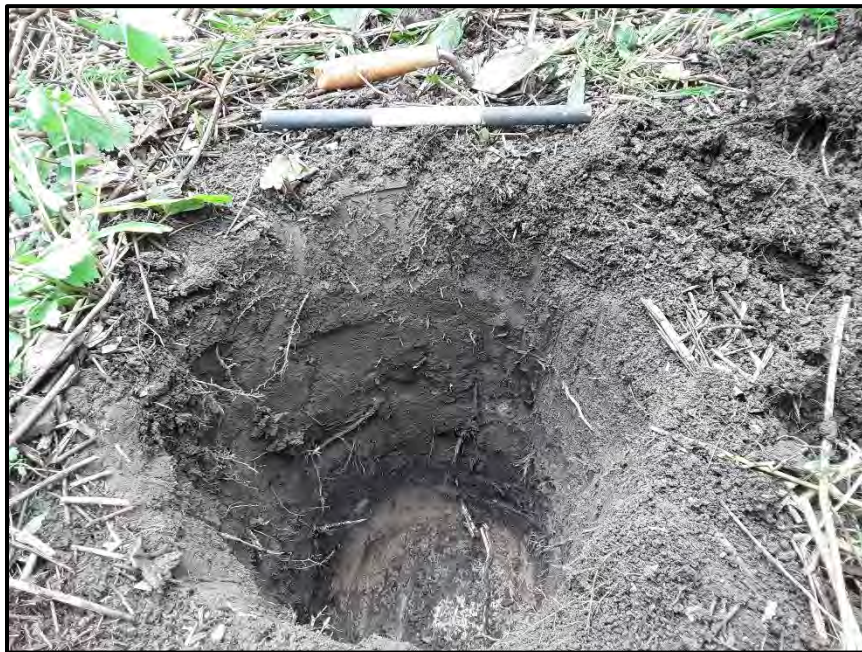
Image 8. Sample test pit showing an undisturbed soil profile, facing west. (PR24-007D035)

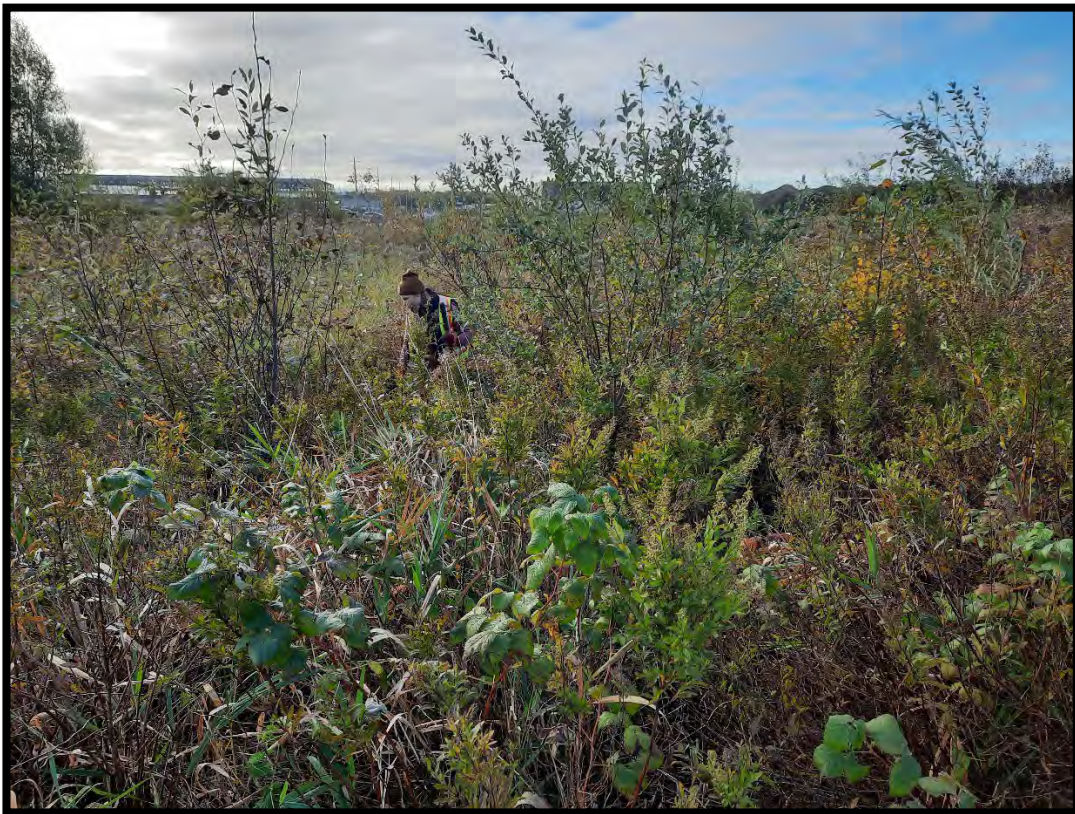
**Figure 8: Test pitting central forested section of Robot Street extension (MH1326-D019).**

A small portion of the eastern parcel was forested. This section, about 50x20m in diameter, was shovel tested at 5m intervals (Figure 8). All test pits were a minimum of 30cm in diameter and were excavated 5cm into subsoil and extended to within 1m of structures (Section 2.1.2). All soil was screened using 6mm mesh screens. All test pits were examined for cultural features and stratigraphy, then backfilled upon completion. Nothing of archaeological significance was identified within the test pit portion of the study area.

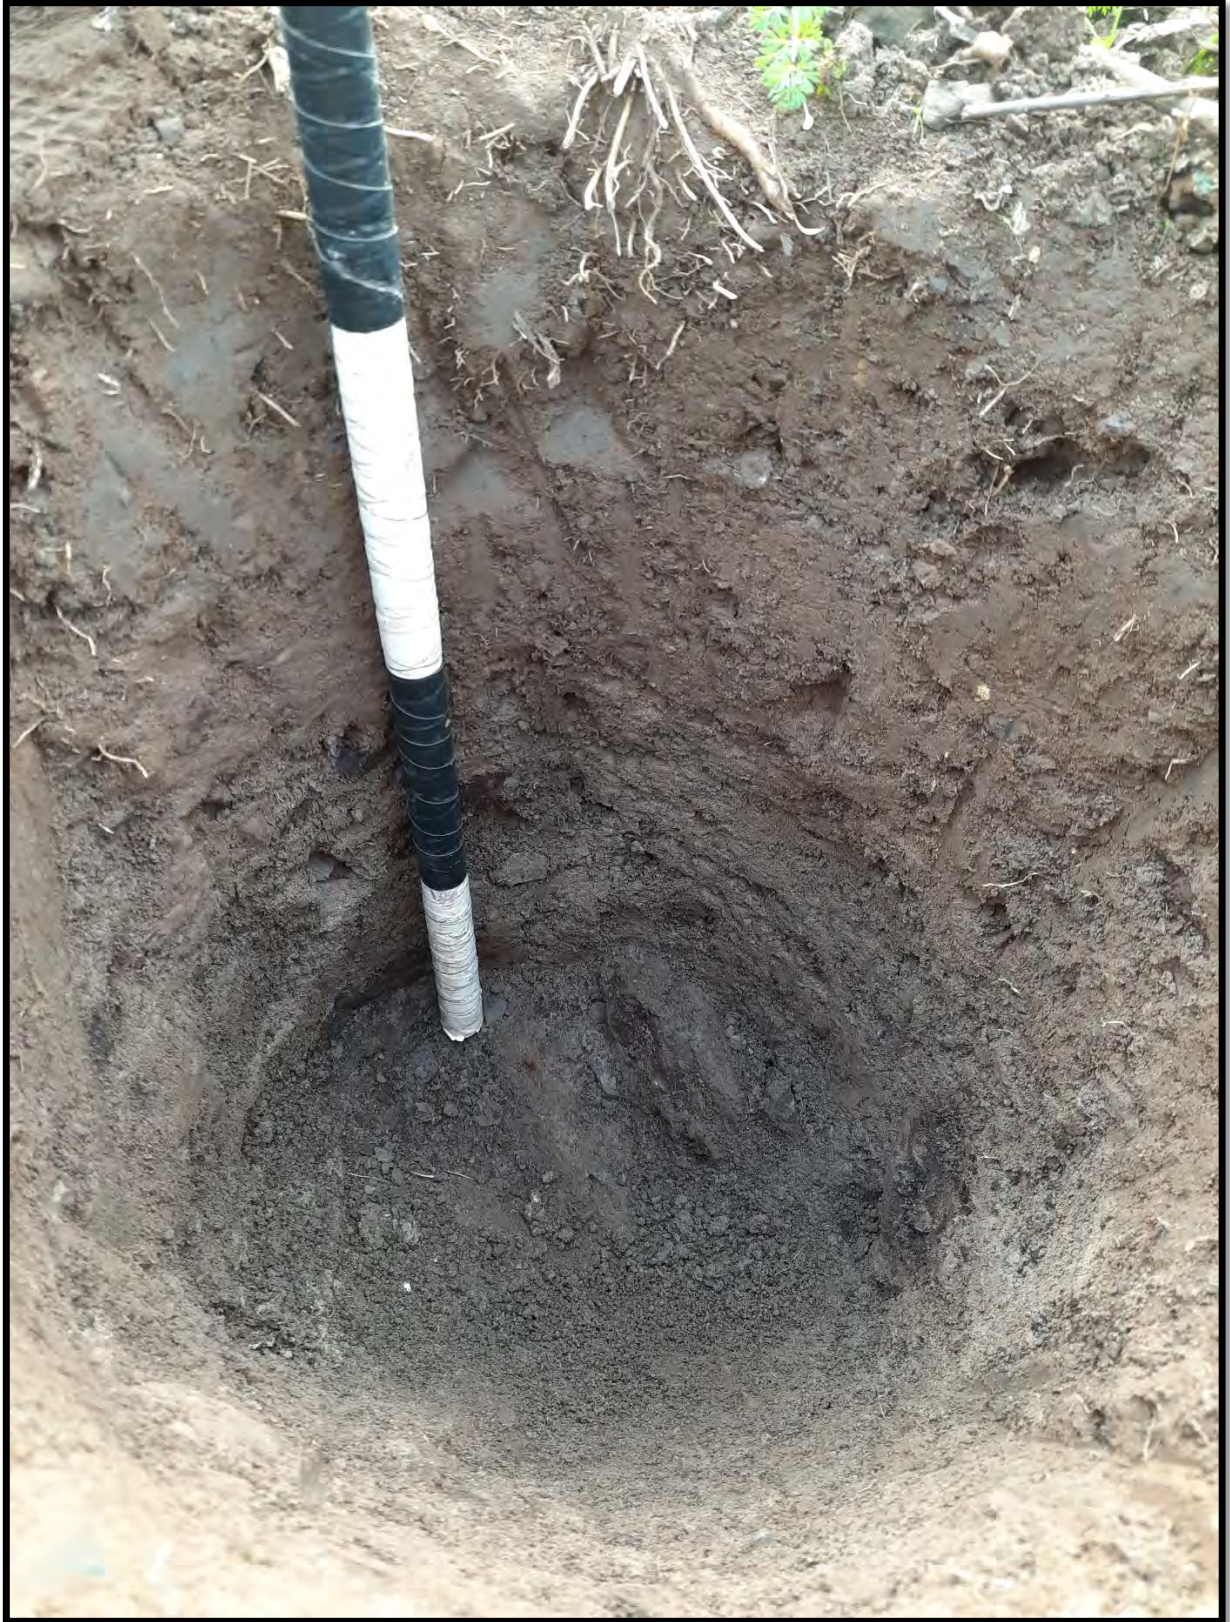
**Figure 9: Typical stratigraphy found throughout test pitting section of Robot Street extension (MH1326-D027).**

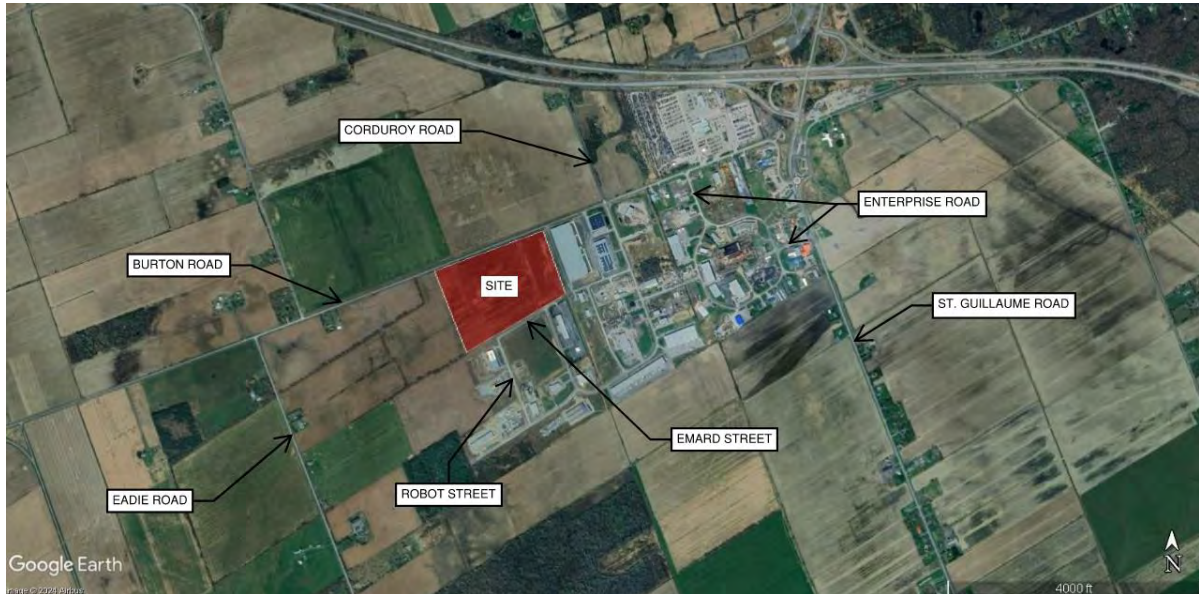
**Figure 1: Site Location**

The municipal address of the proposed development is currently unknown. The subject lands are generally situated within the area bound by Burton Road to the north, Emard Street to the south, and Corduroy Road to the east, as shown in **Figure 1**.

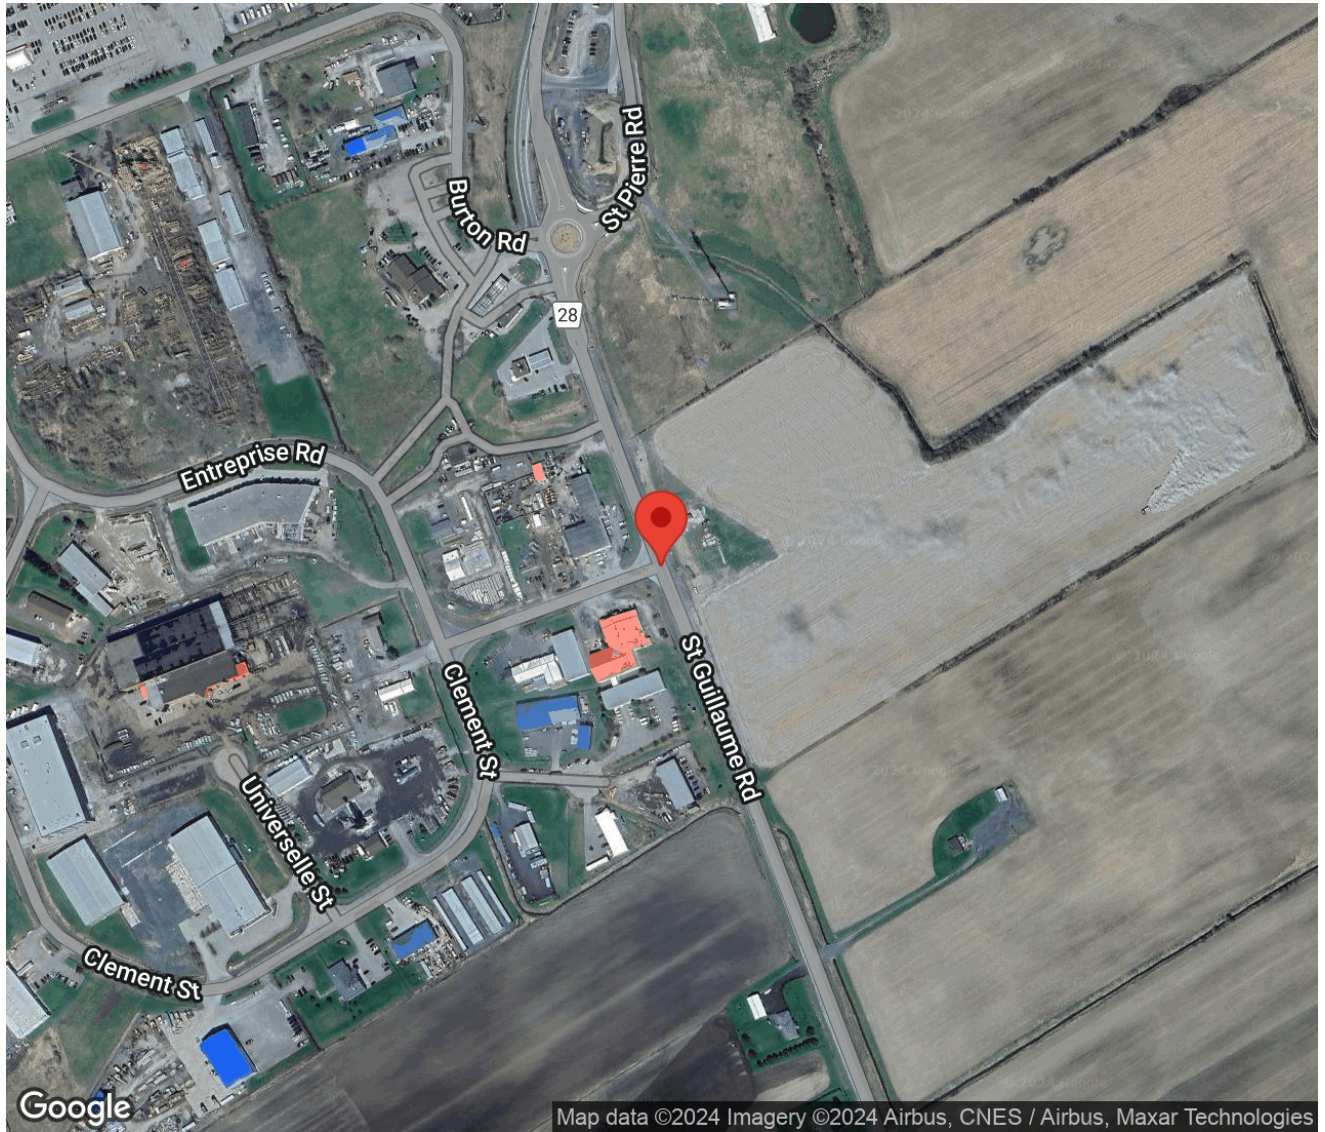
Intersection: St. Guillaume Rd & Enterprise Rd  
Site Code: 2416900021  
Municipality: Russell Twp  
Count Date: Apr 24, 2024

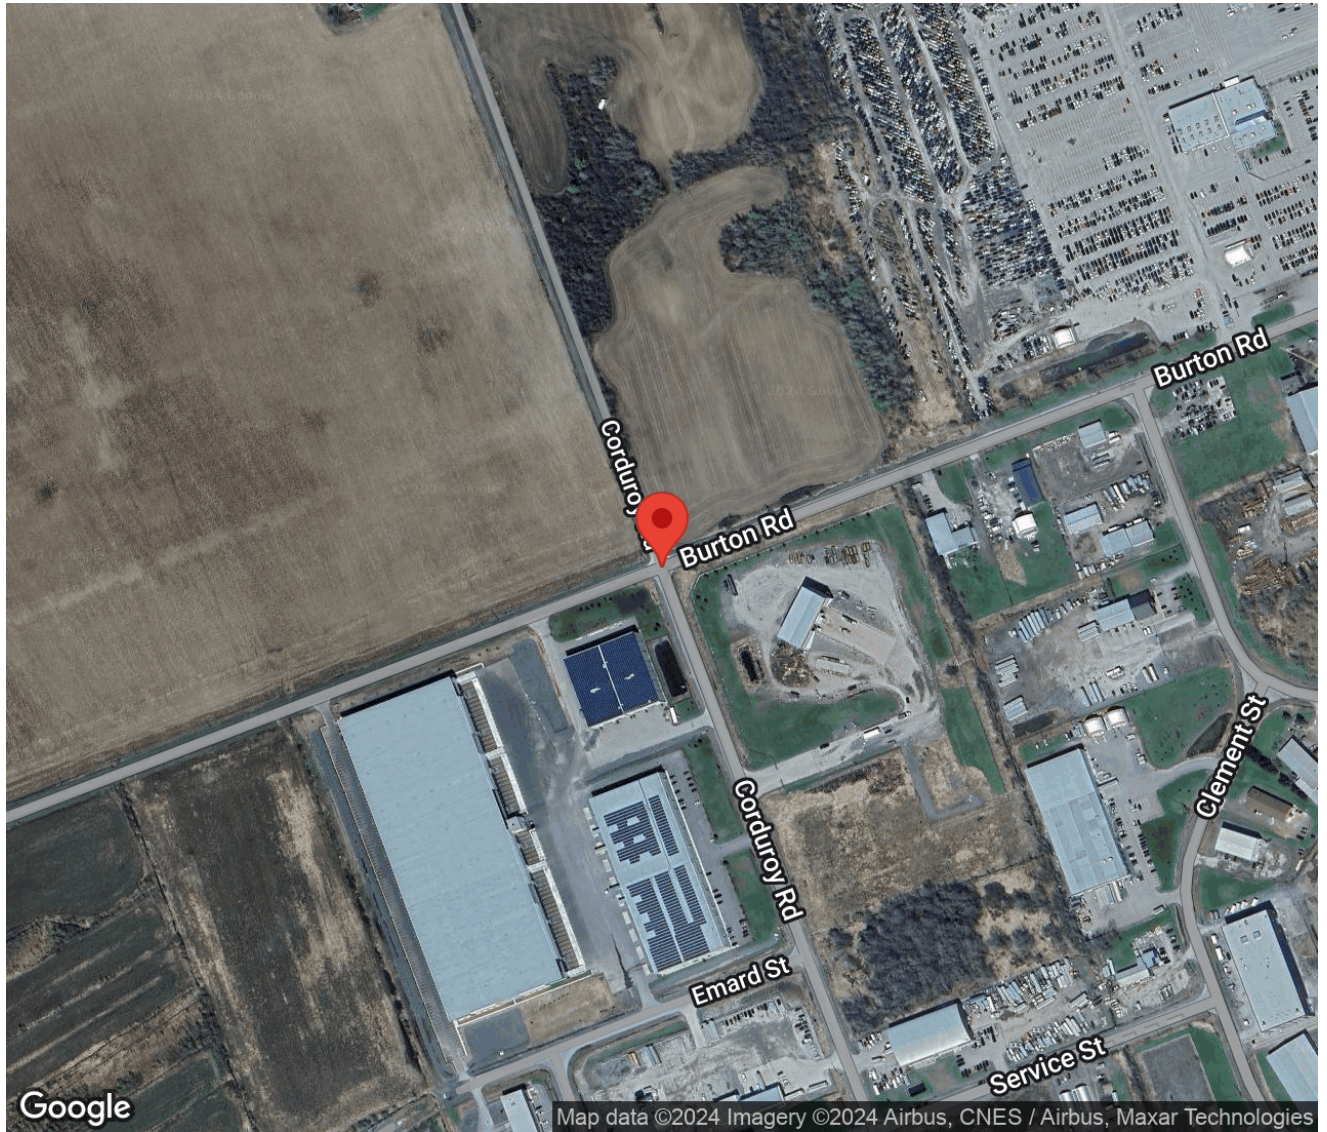
Intersection: Burton Rd & Corduroy Rd  
Site Code: 244660001  
Municipality: Russell Twp  
Count Date: Nov 06, 2024

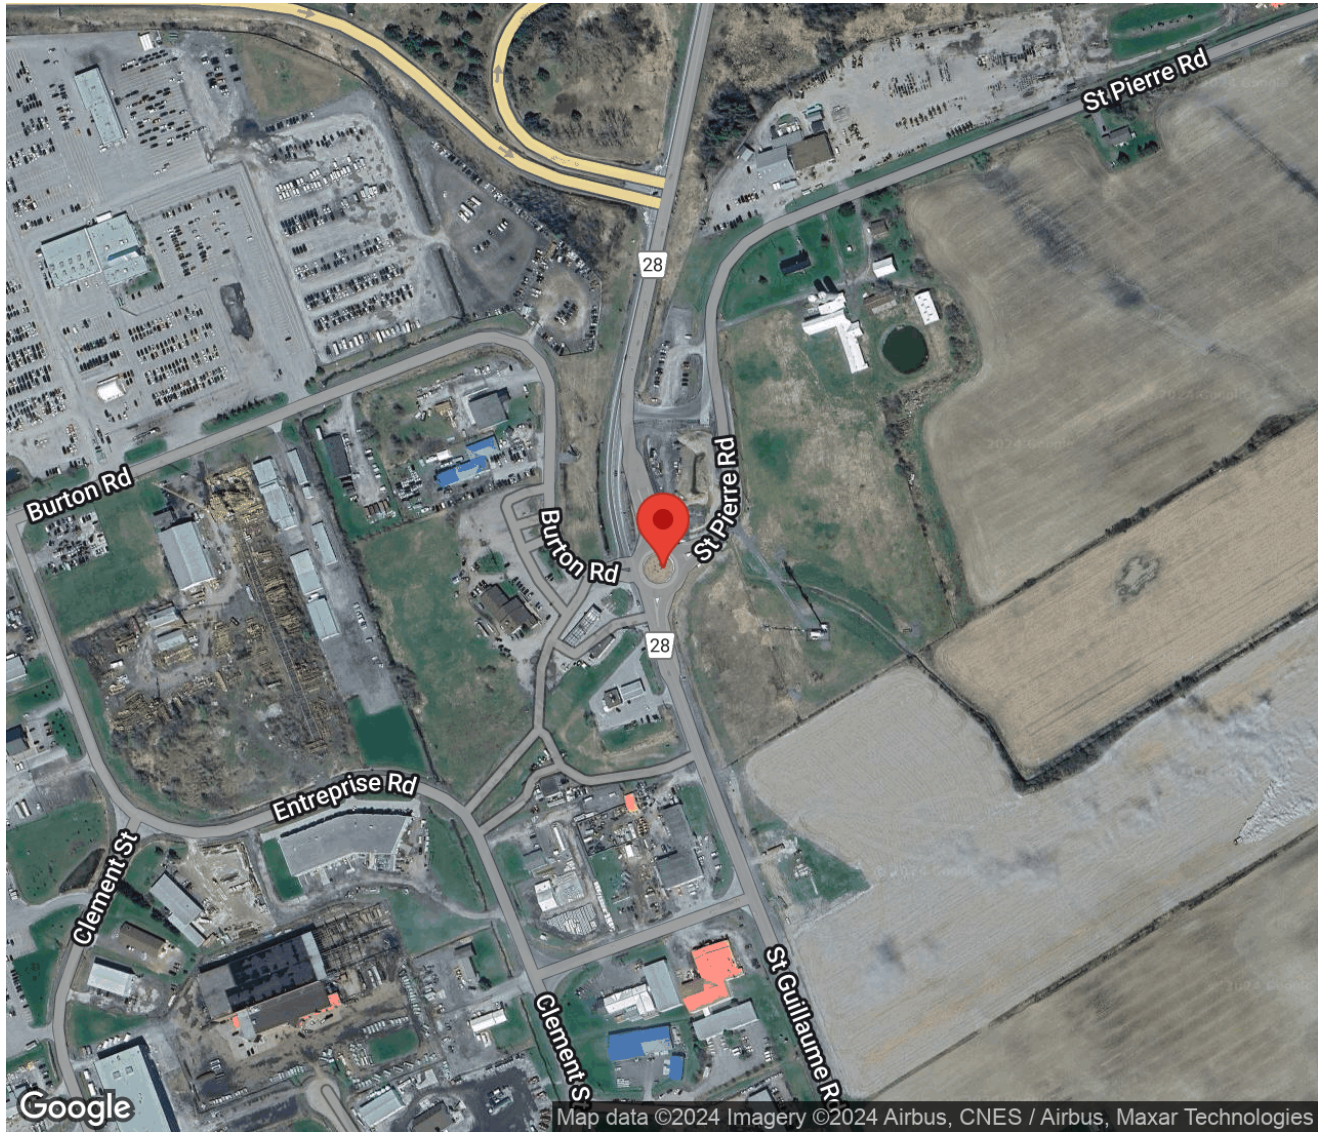
Intersection: St. Guillaume Rd & Burton Rd - St Pierre Rd  
Site Code: 2416900020  
Municipality: Russell Twp  
Count Date: Apr 24, 2024

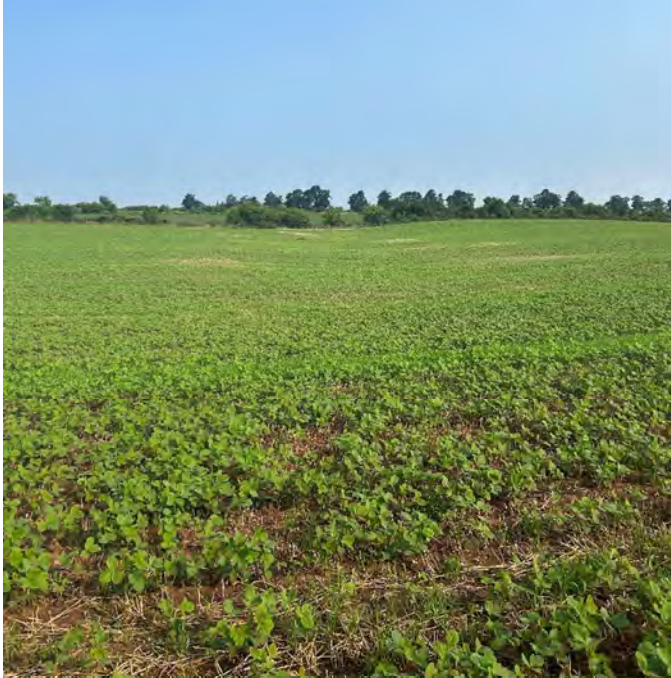
Photograph No. 3

Date: 8/14/2024	
Description Southwestern corner of the Site facing North. Shows the hilly topography of the Site.

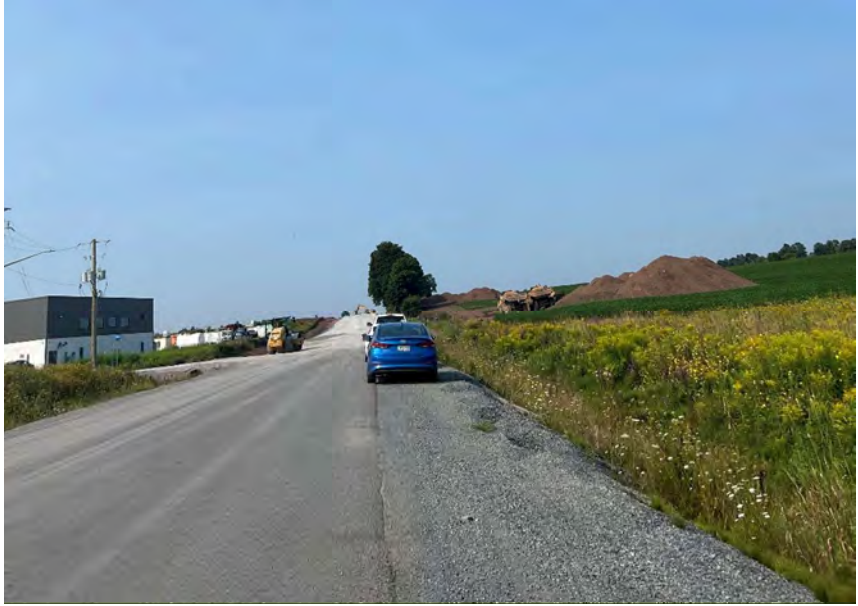
Photograph No. 10

Date: 6/11/2024	
Description  Emard Street and Robot Street intersection facing the west towards the on-going extension of the road into the central portion of the Site.

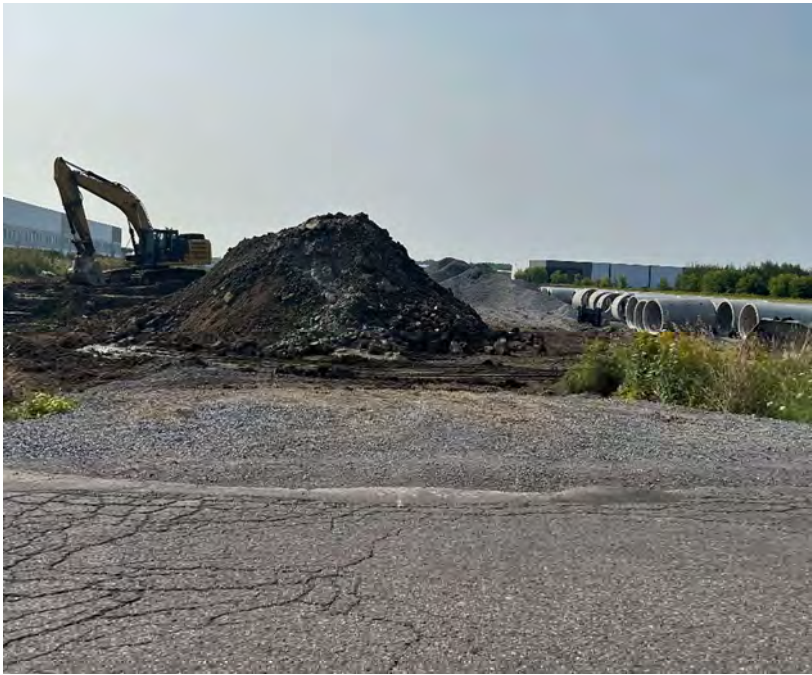
<p>Photograph No. 12</p>

<p>Date: 8/14/2024</p>	
<p>Description</p> <p>Northeastern extent of the Site facing the south towards the on-going sewer construction along the eastern portion of the Site.</p>
